# Rebuilt Sill Plates

# Foundation Work

# Net zero energy improvements

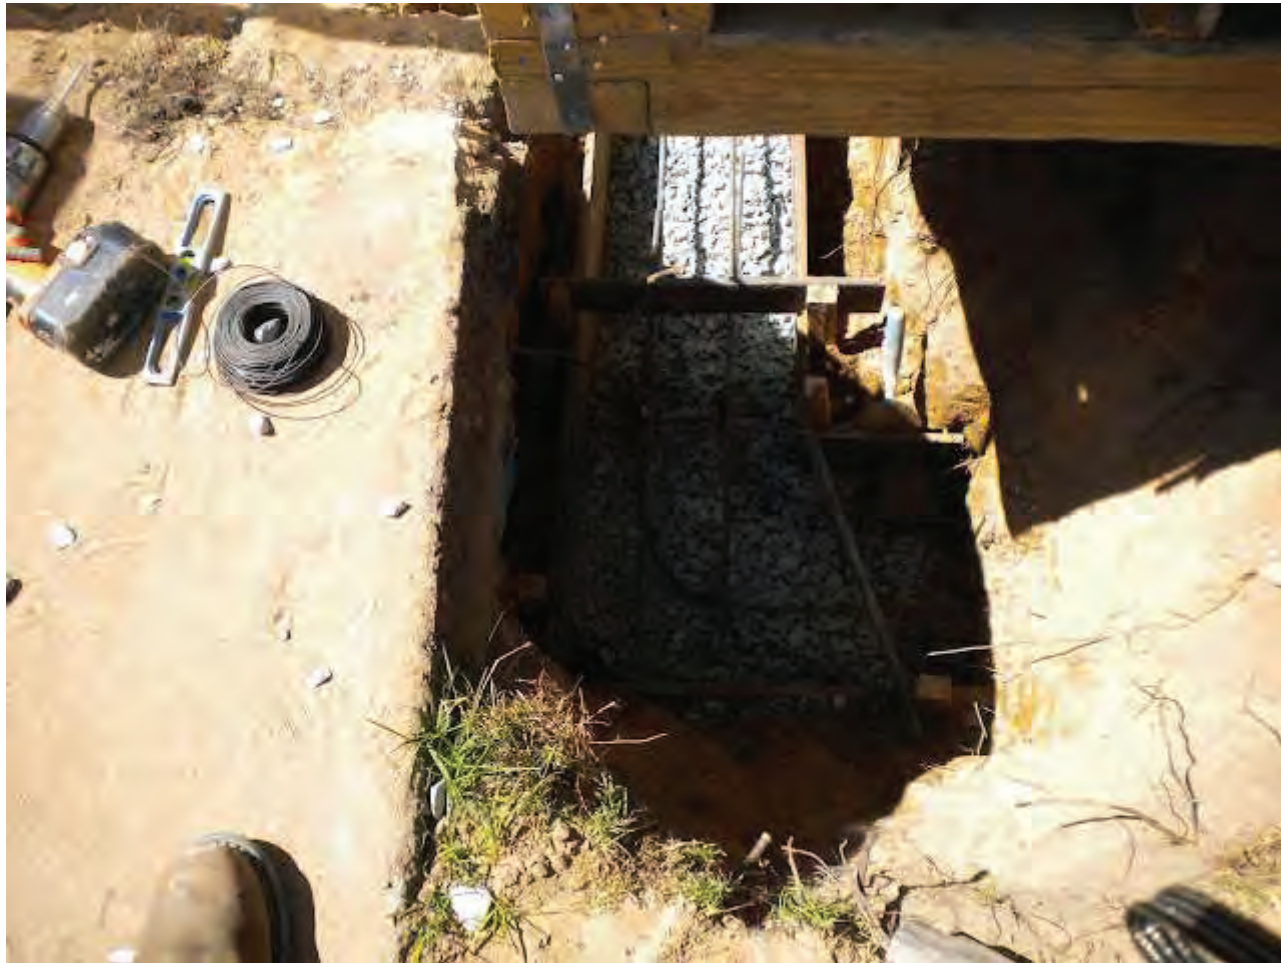
**new foundation under kitchen**

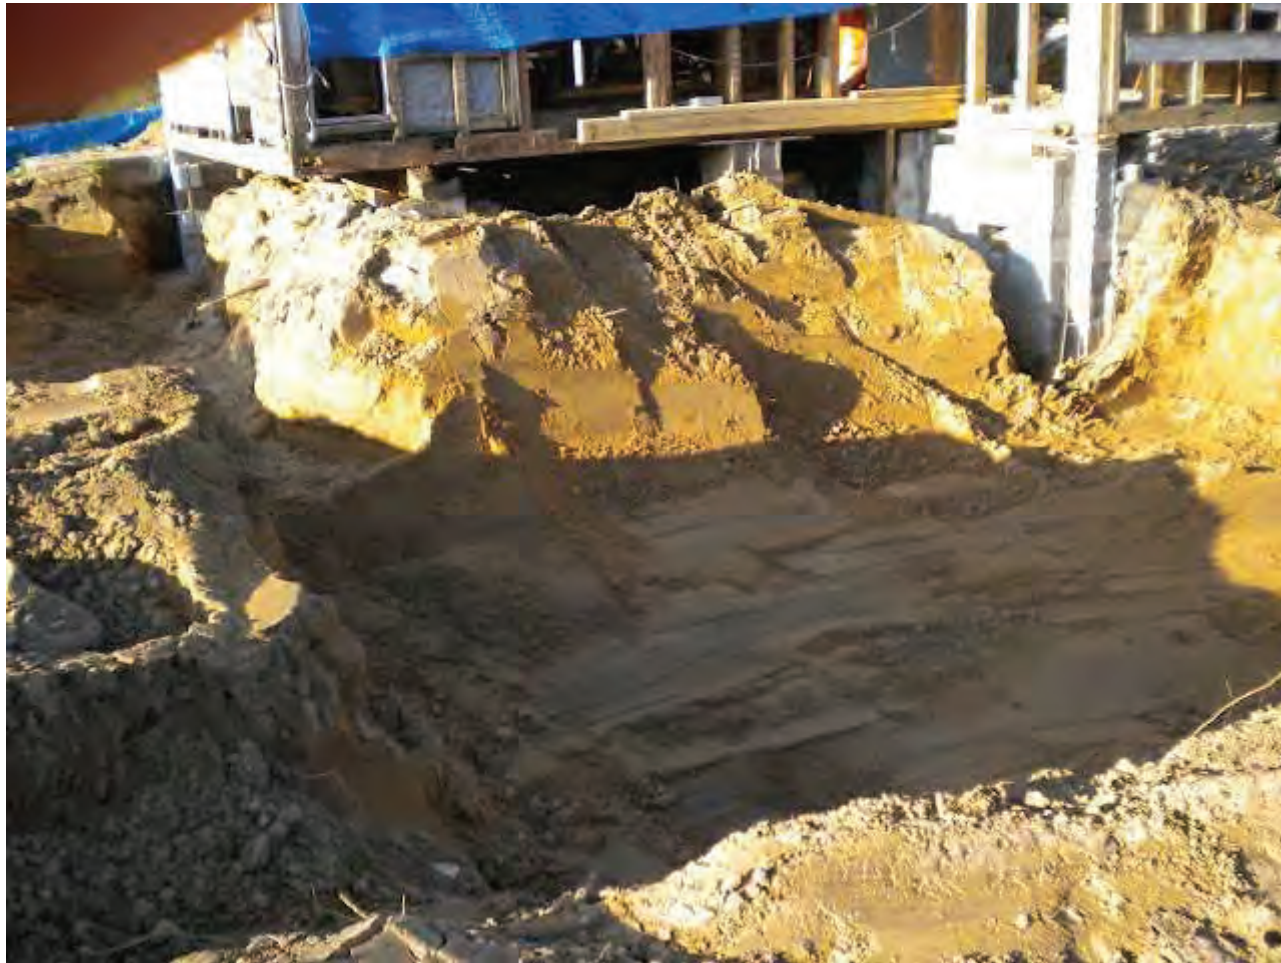
**excavating for kitchen extension**

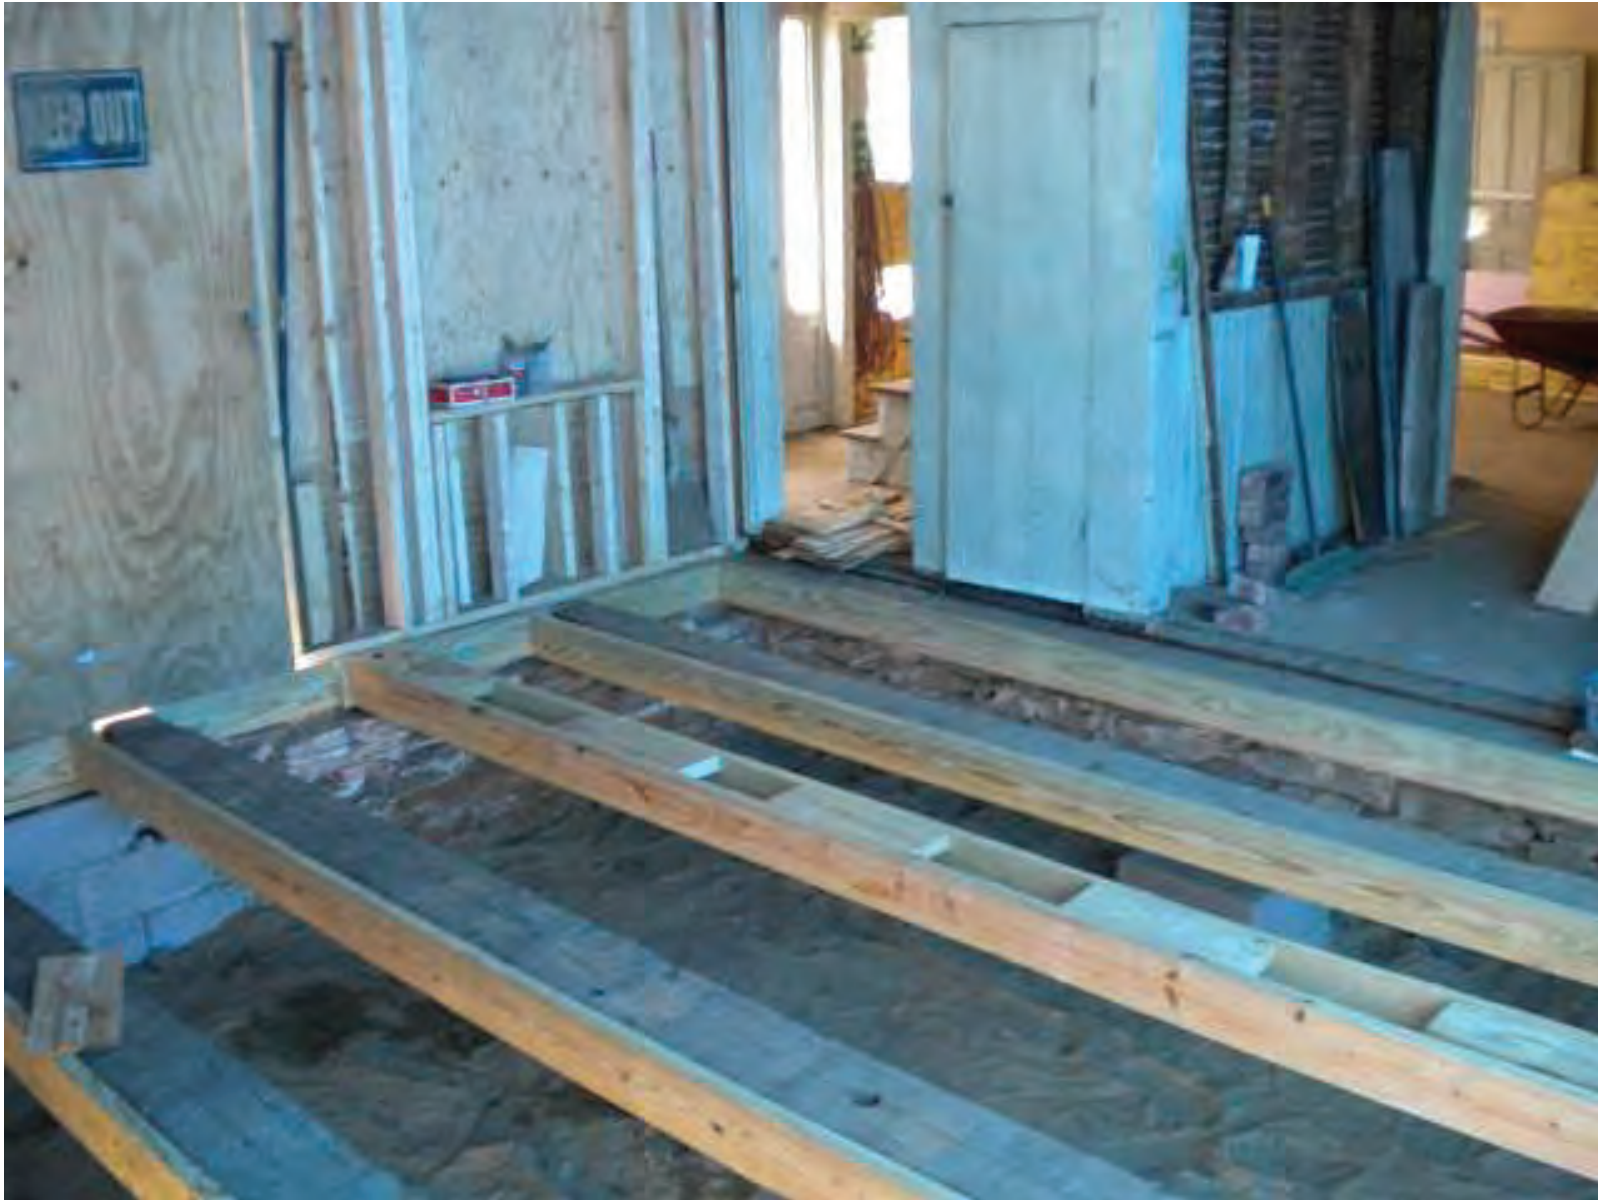
**kitchen floor structure**

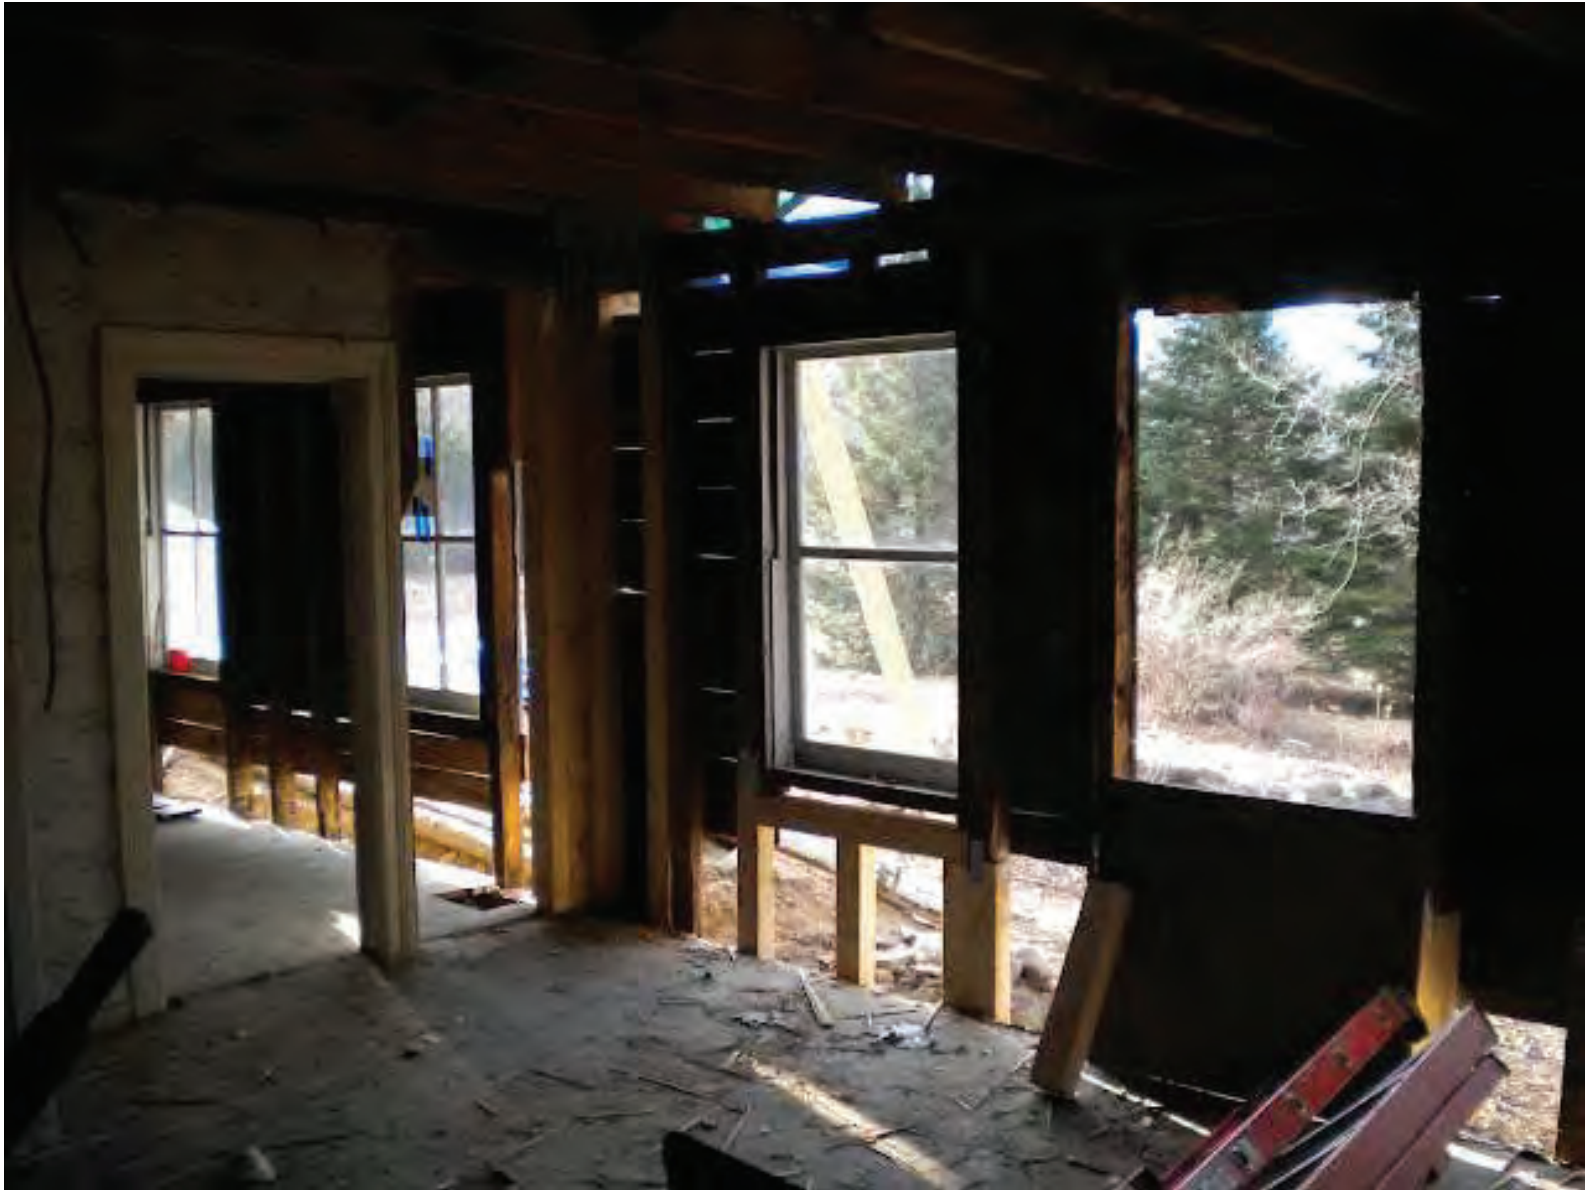
**structural repair master bedroom and living room**

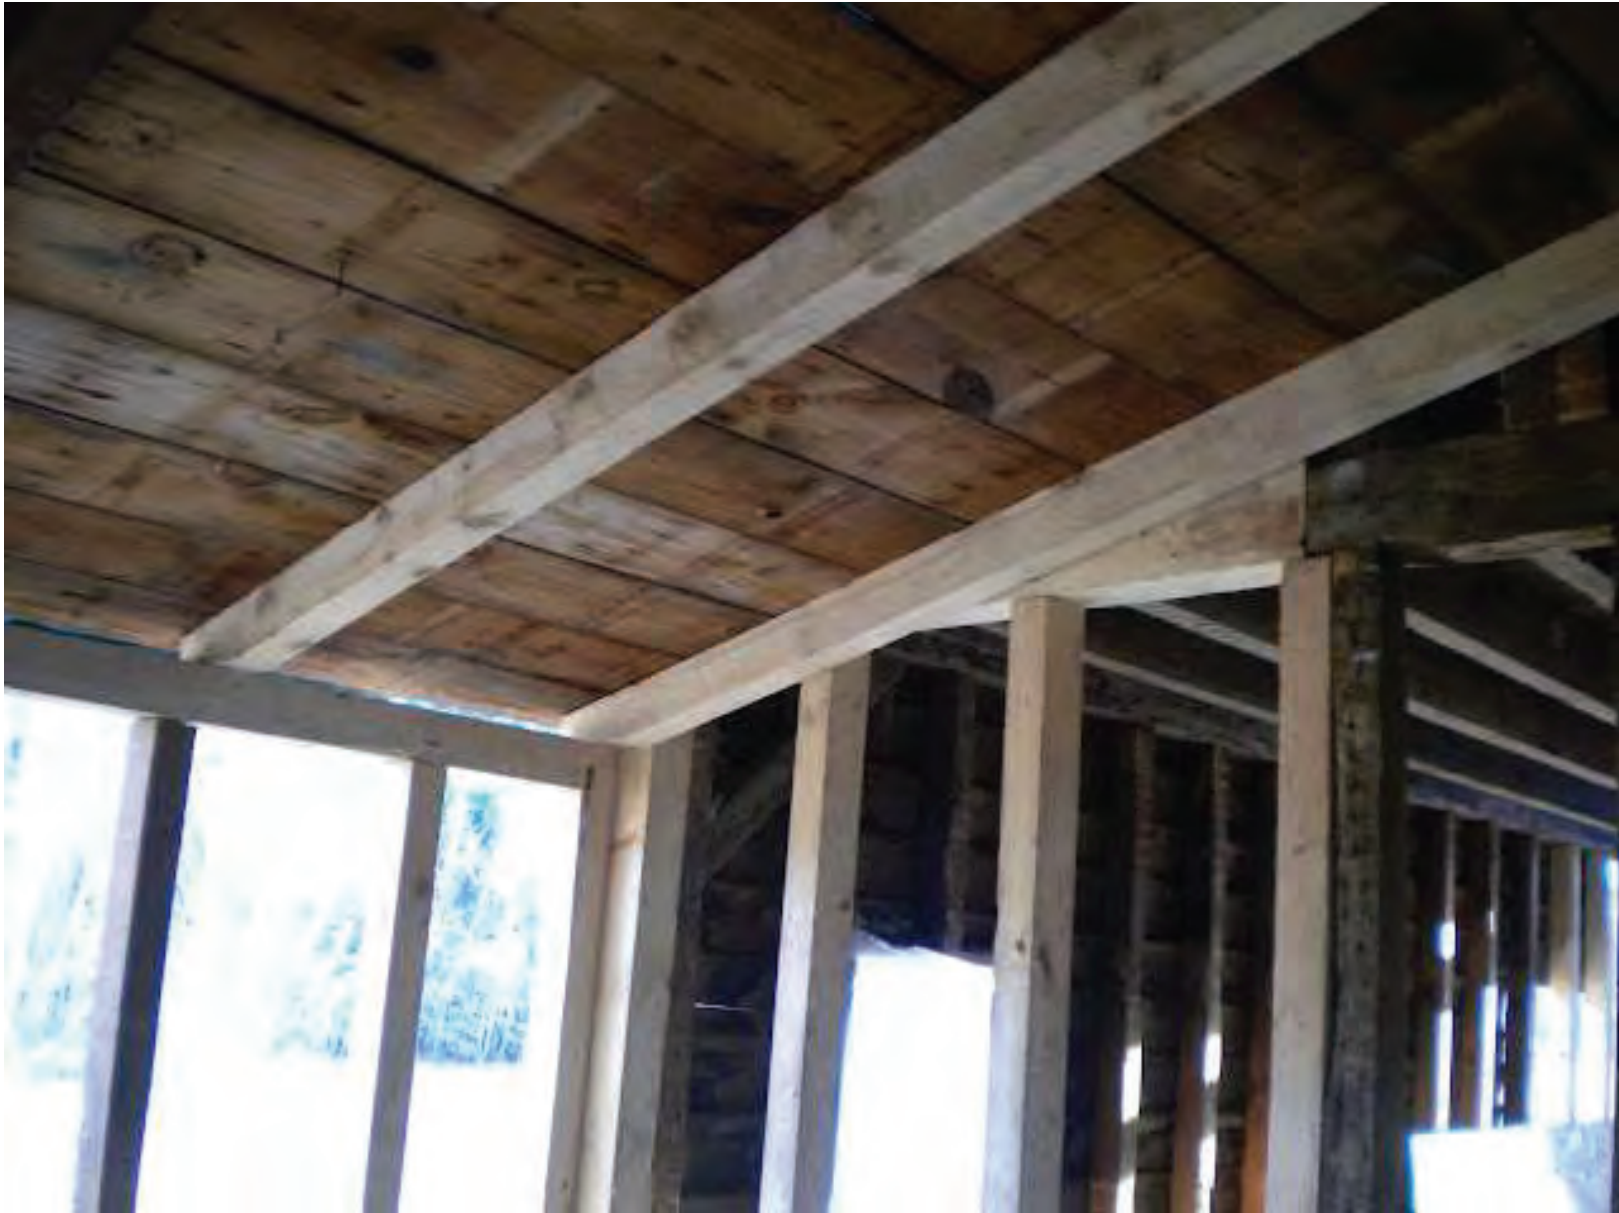
**structural repair in master bath removing frozen sawdust**

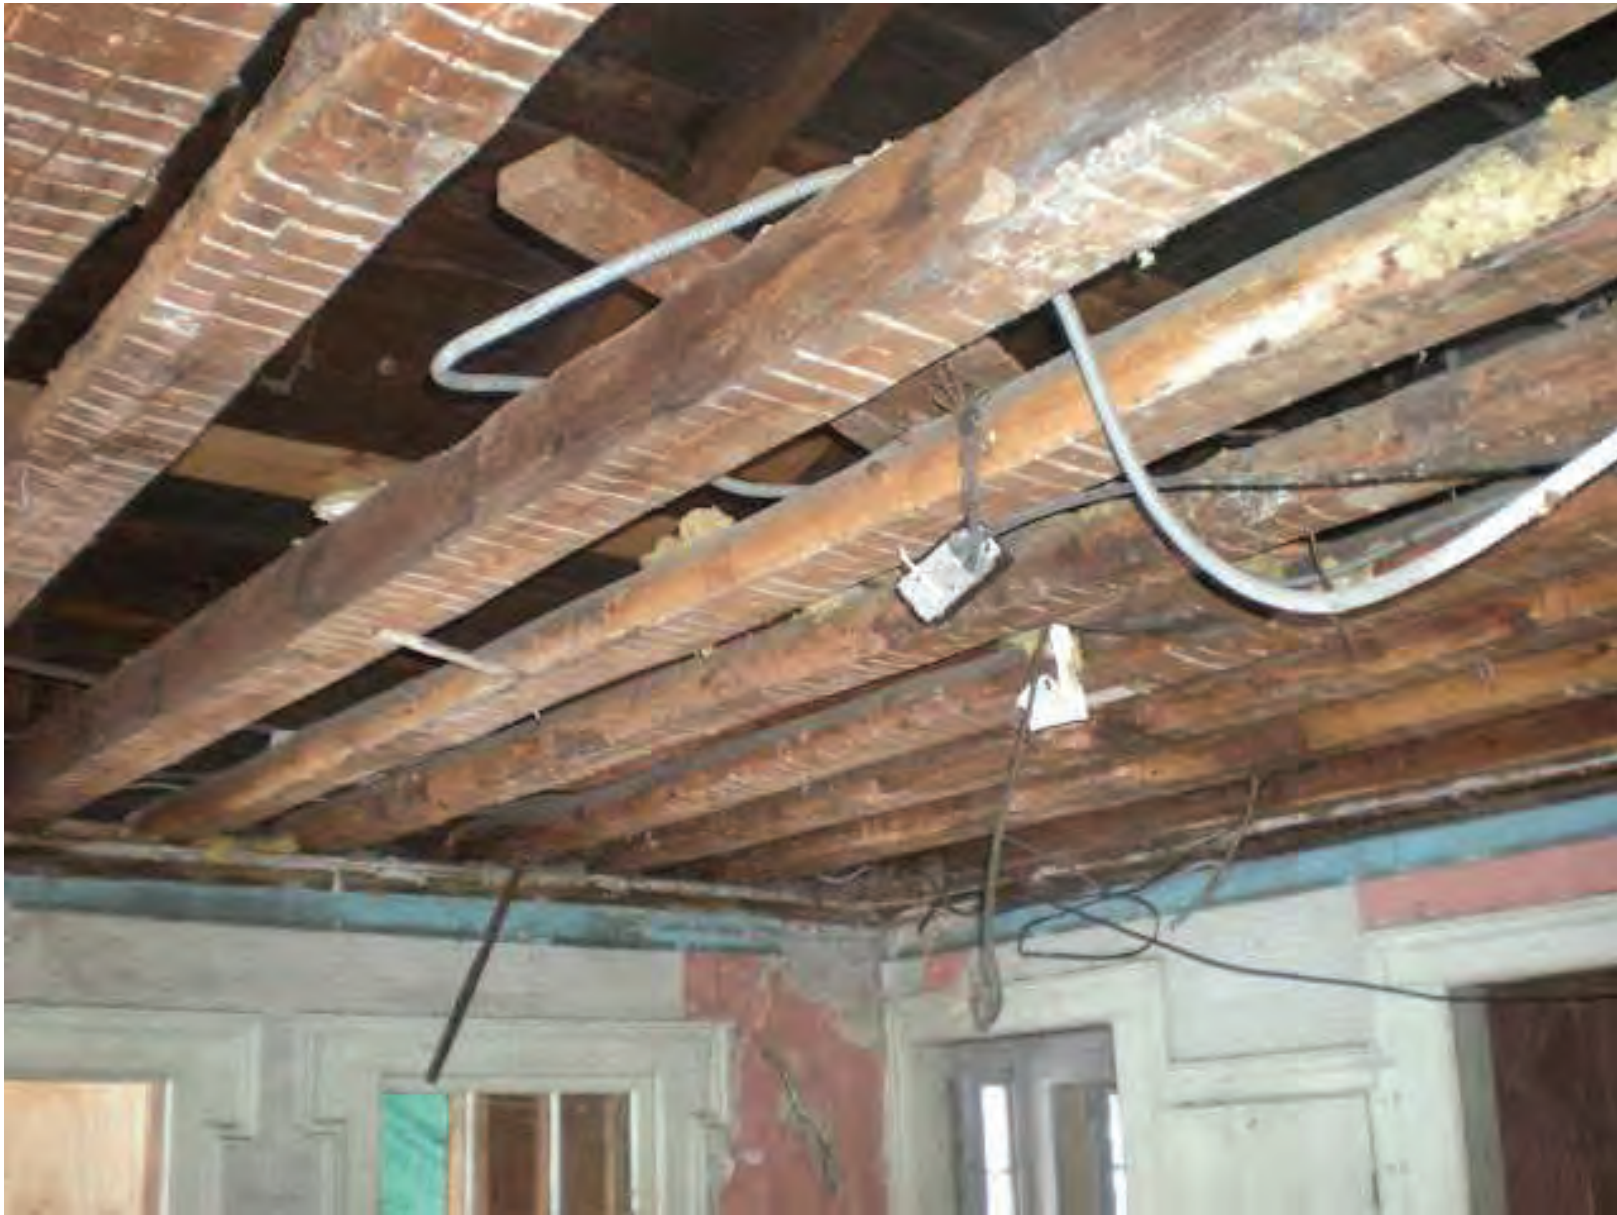
**Kitchen ceiling joists reused as roof collar ties**

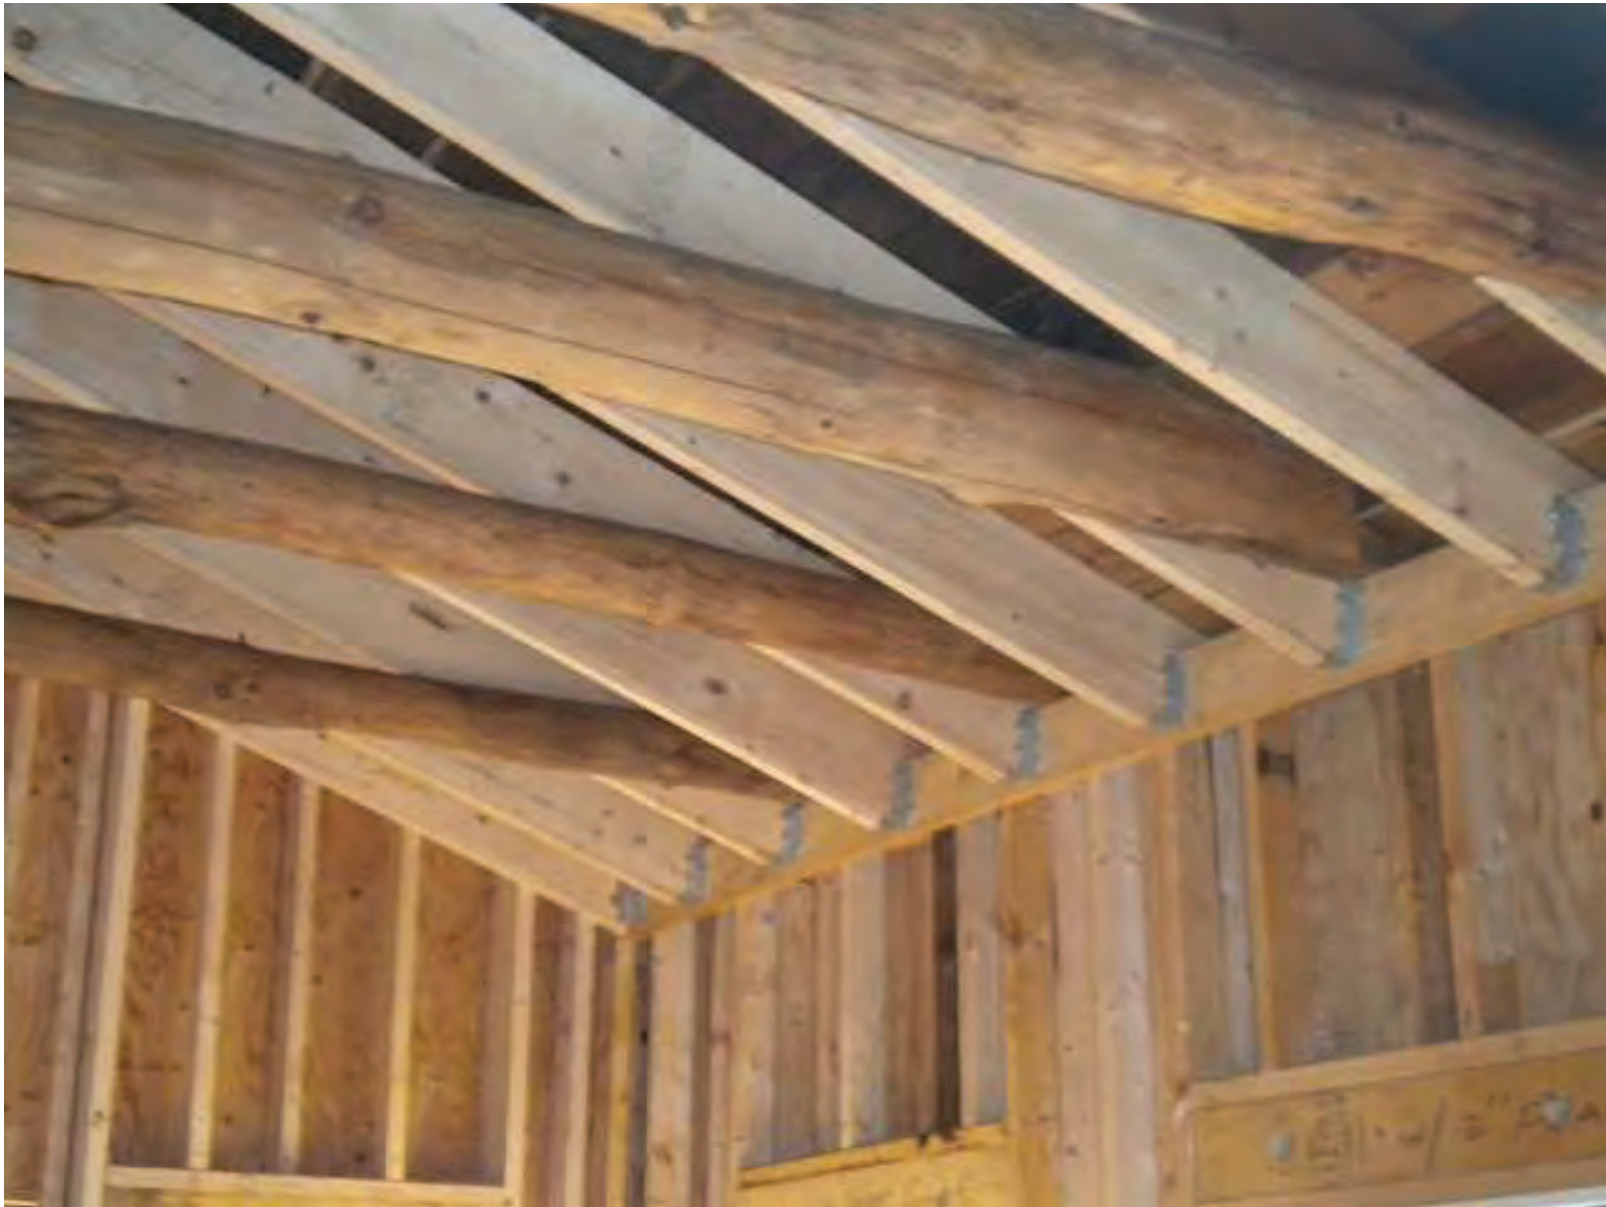
**hurricane clamps and collar ties bolted for secure structure**

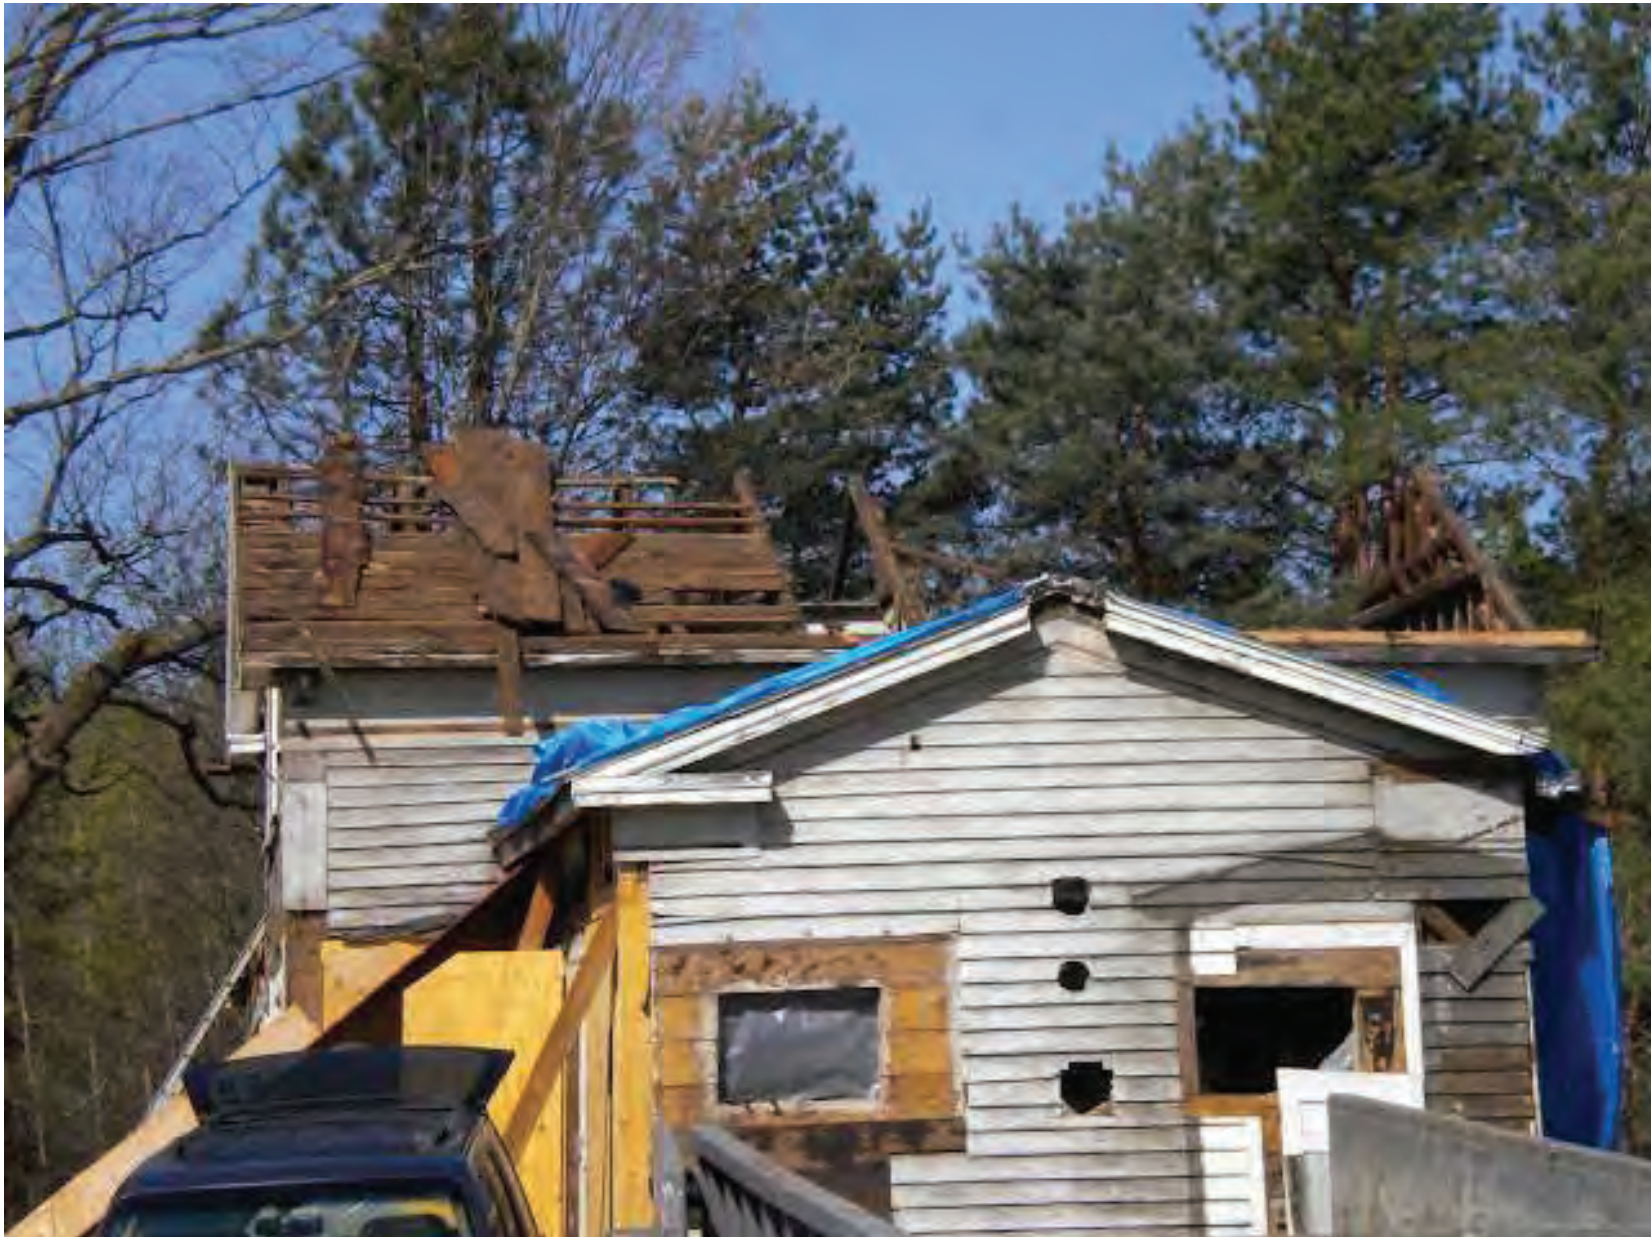
**Demolishing and replacing roof deck**

Greek revival style overhang and return  
Because of structural issues the roof was replaced

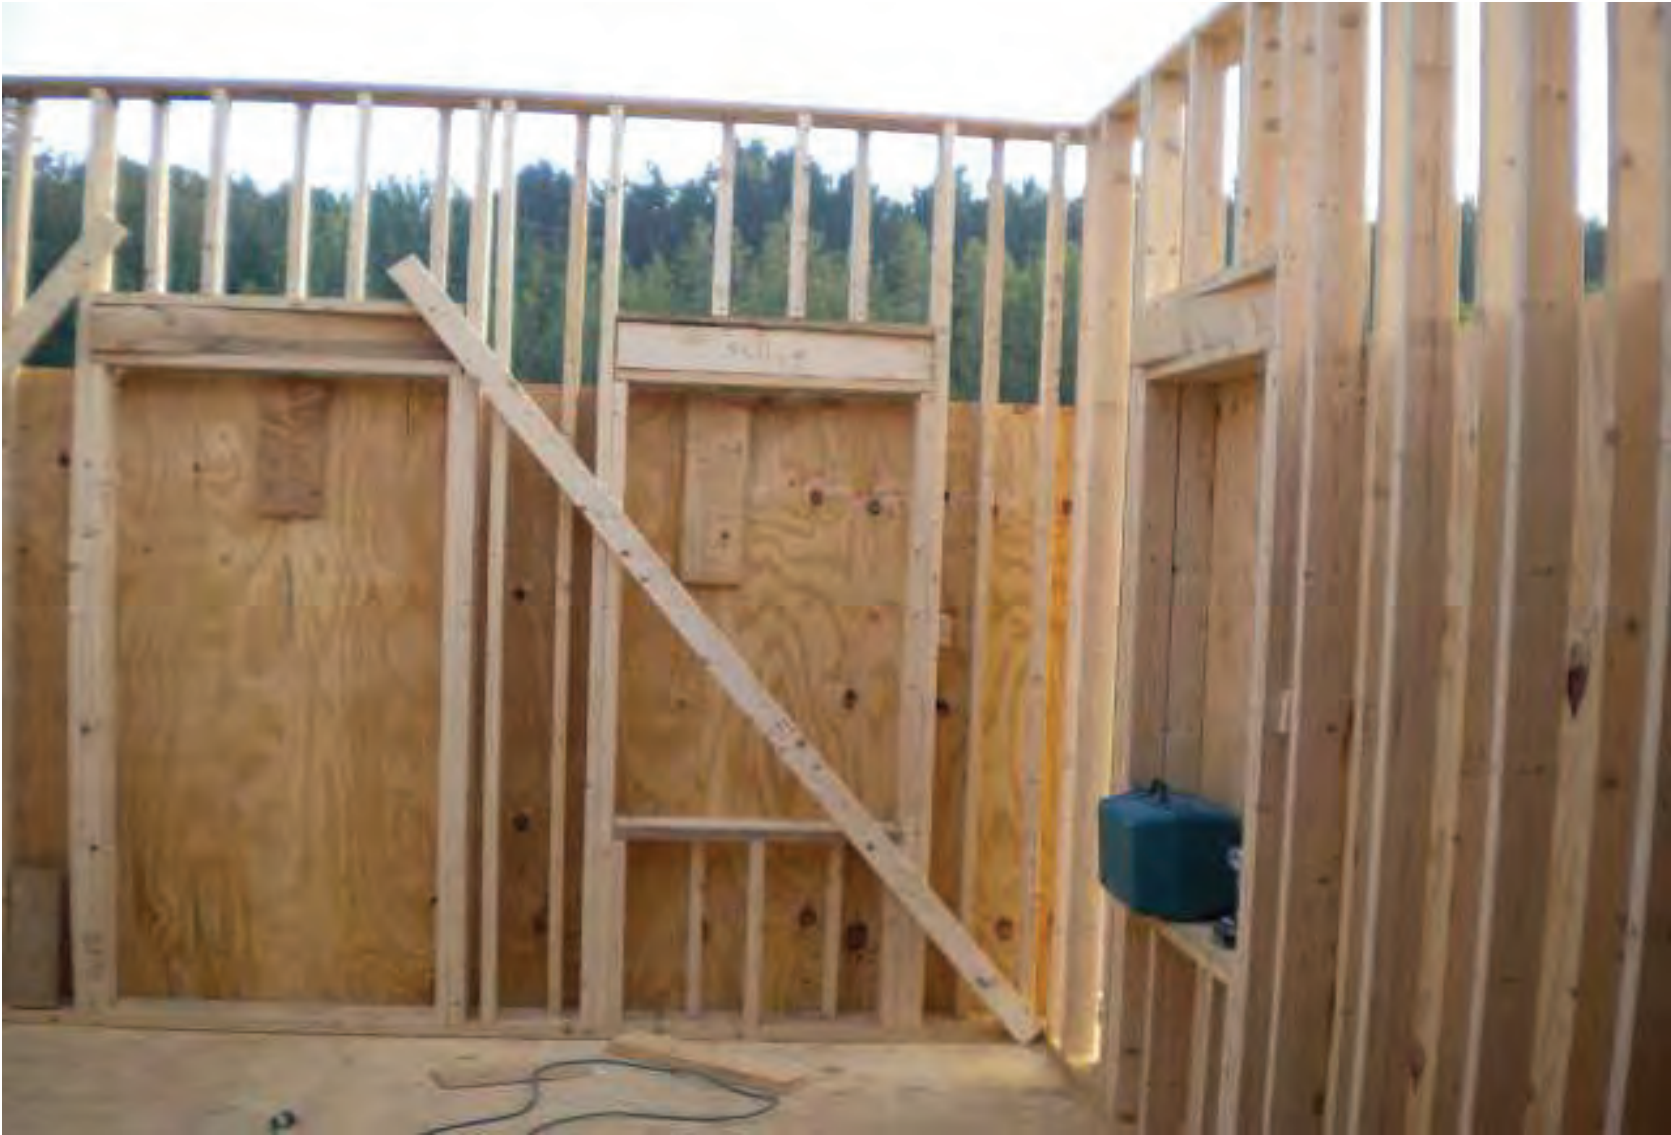
**double studs for depth to obtain R-52 walls**

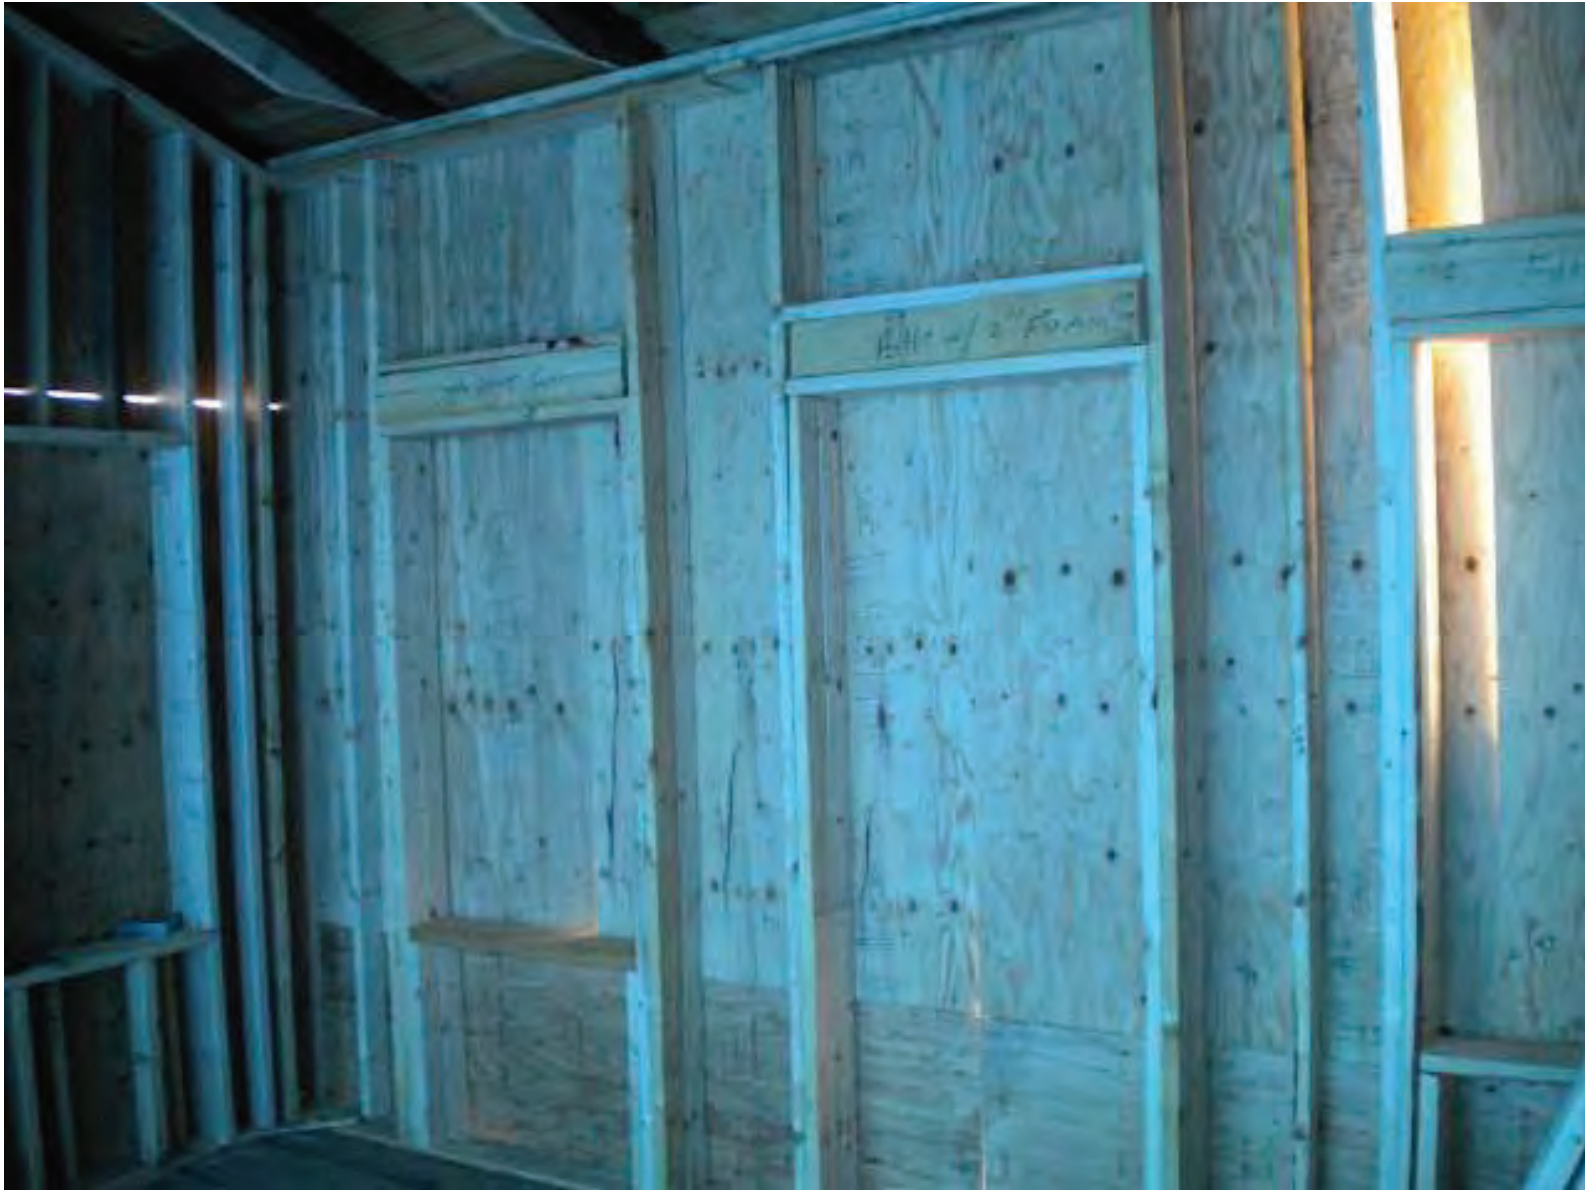
Off set 3" around perimeter, alternating studs for reducing heat transfer

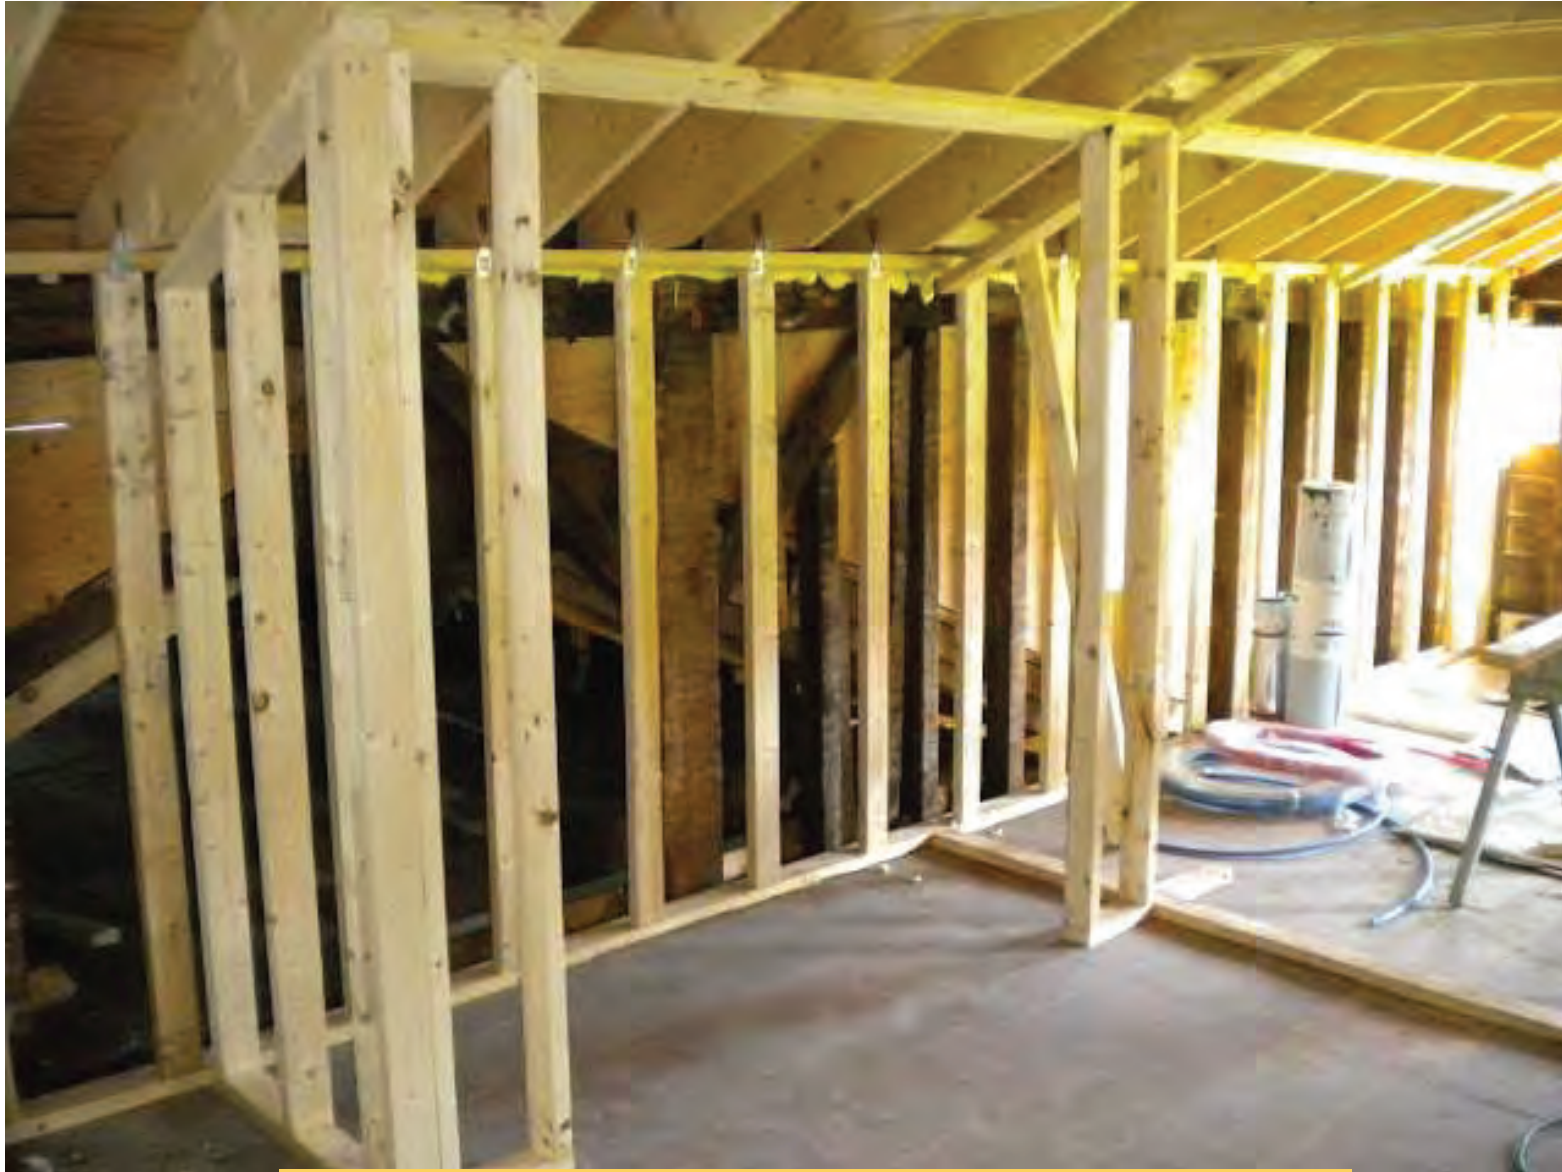
**exterior wall offset to accommodate insulation  
second floor closets**

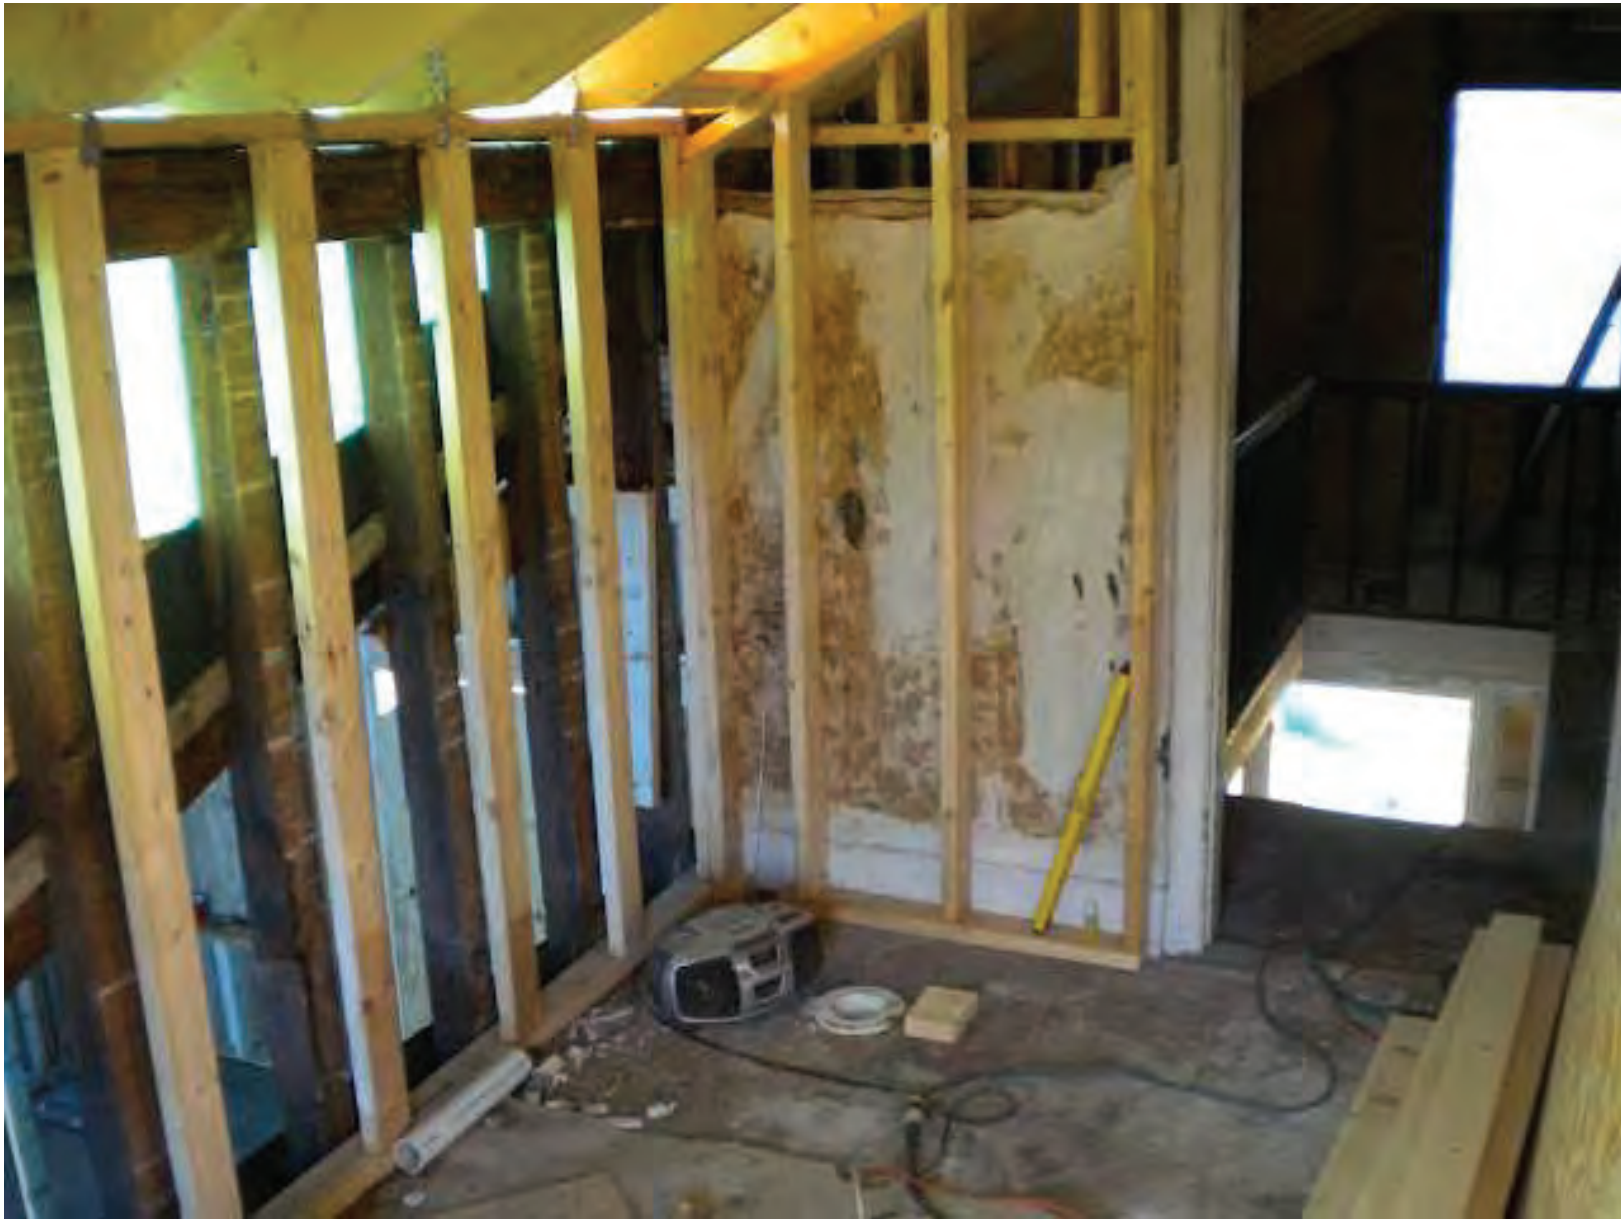
**upstairs bathroom showing off set**

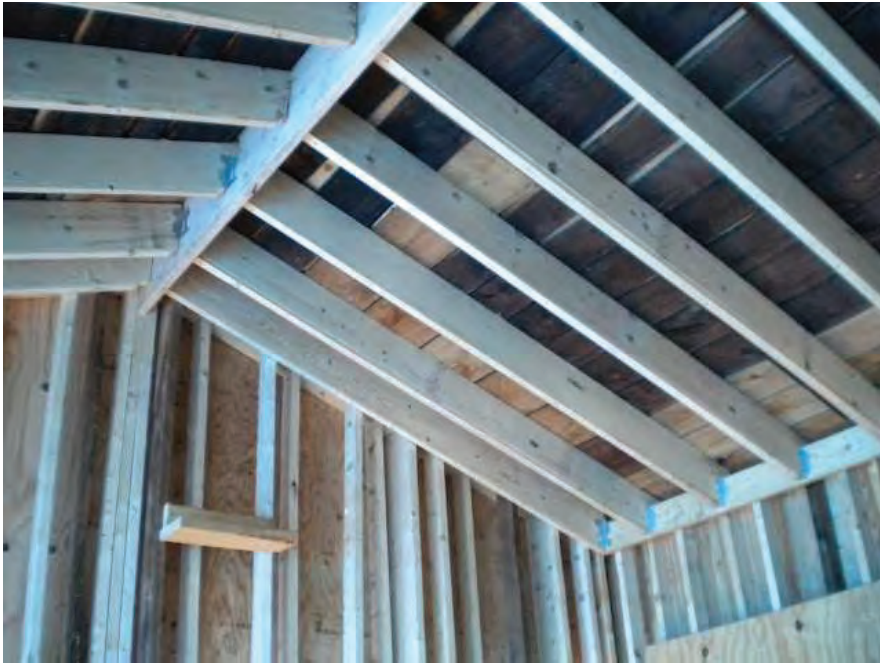
**new kitchen roof structure**

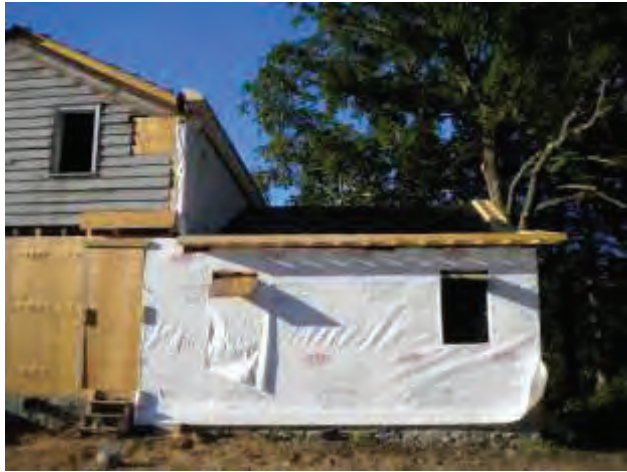
North side roof structure

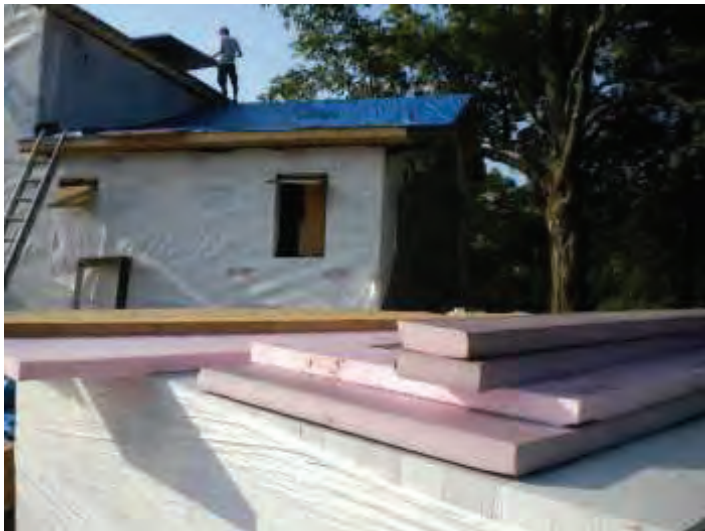
roof insulation being installed  
2 layers of 2" of foam on roof
