# Rebuilt Sill Plates

# Foundation Work

# Net zero energy improvements

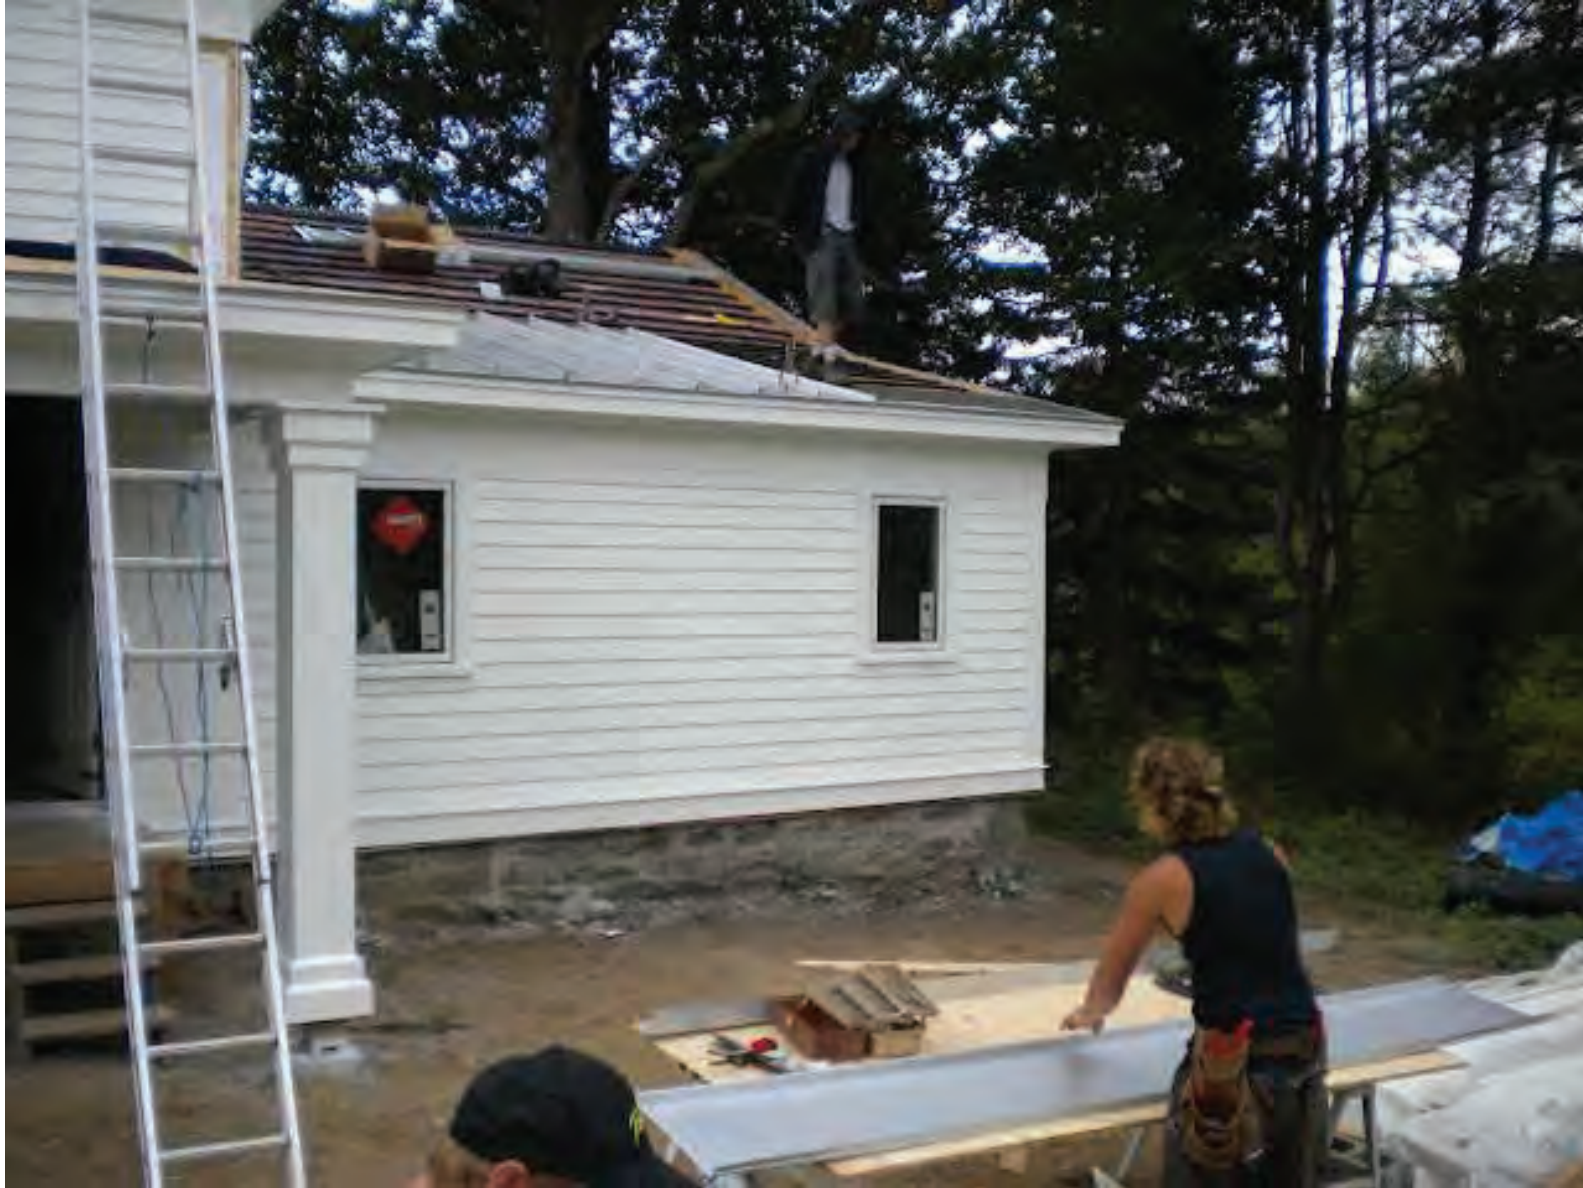
**new metal roofing being installed over furring strips for ventilation**

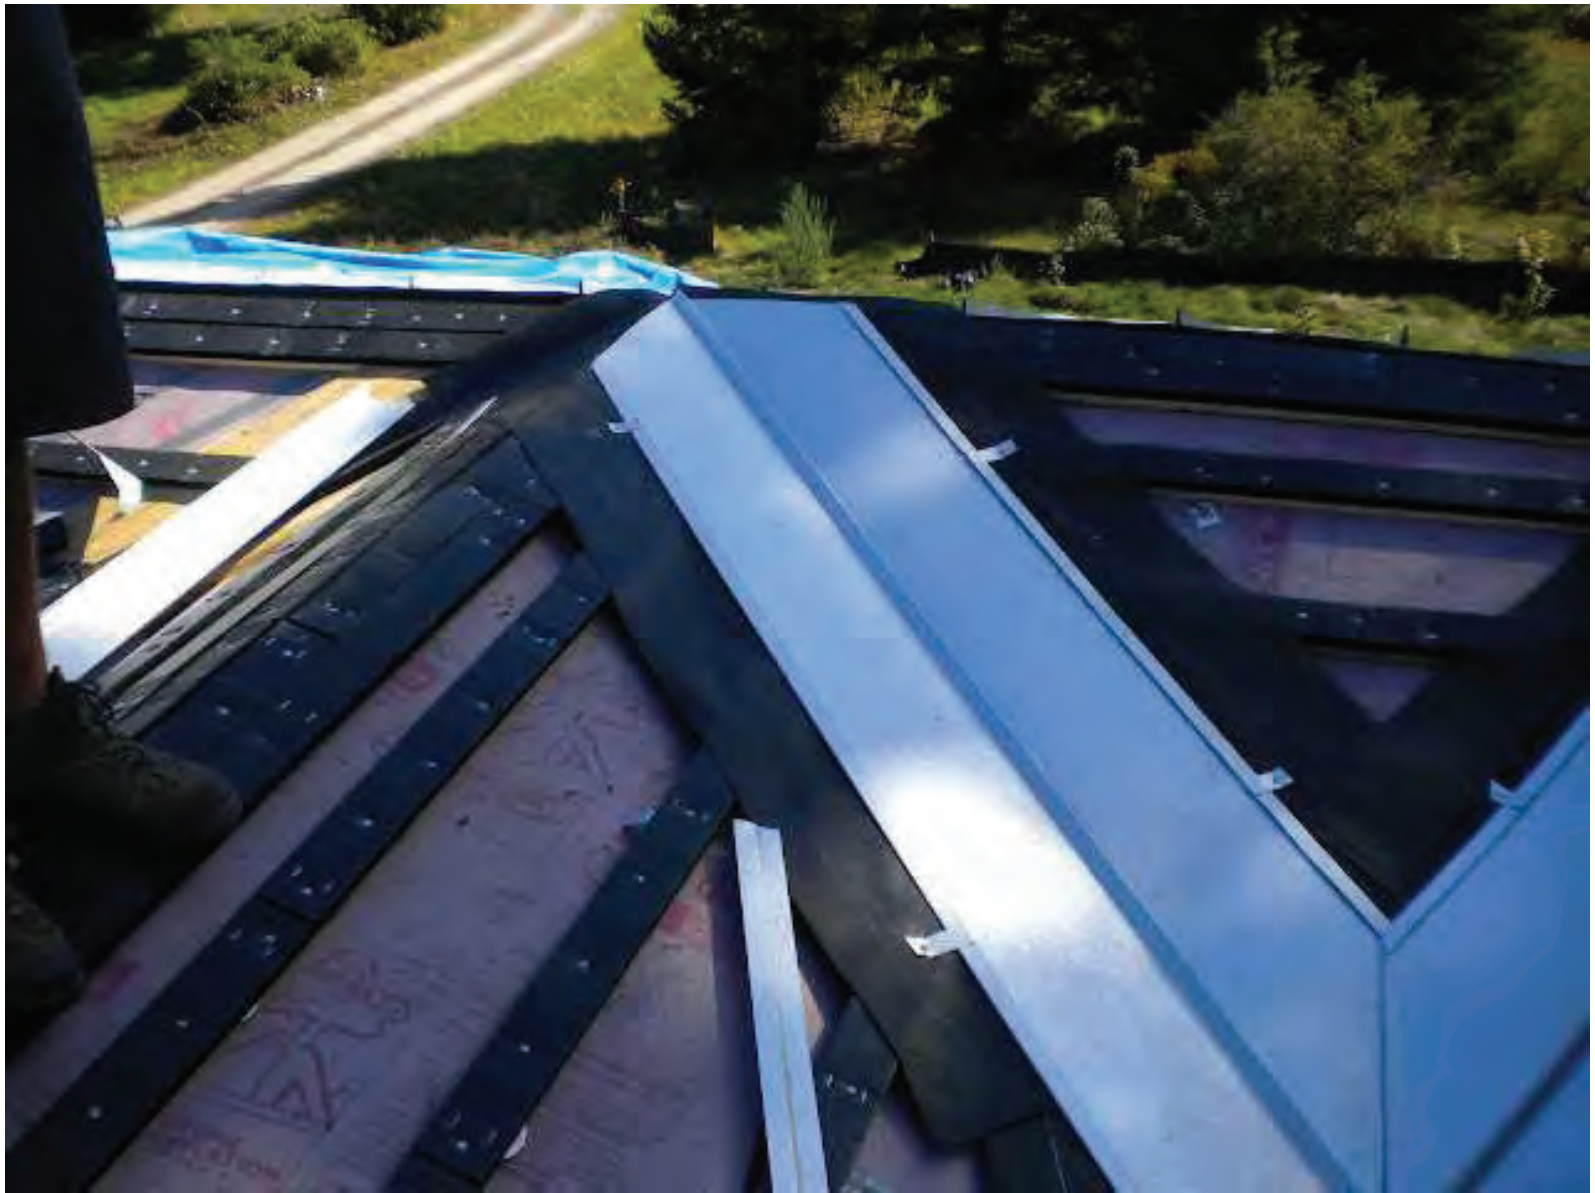
**roof installation detail: ventilated roof perlins**

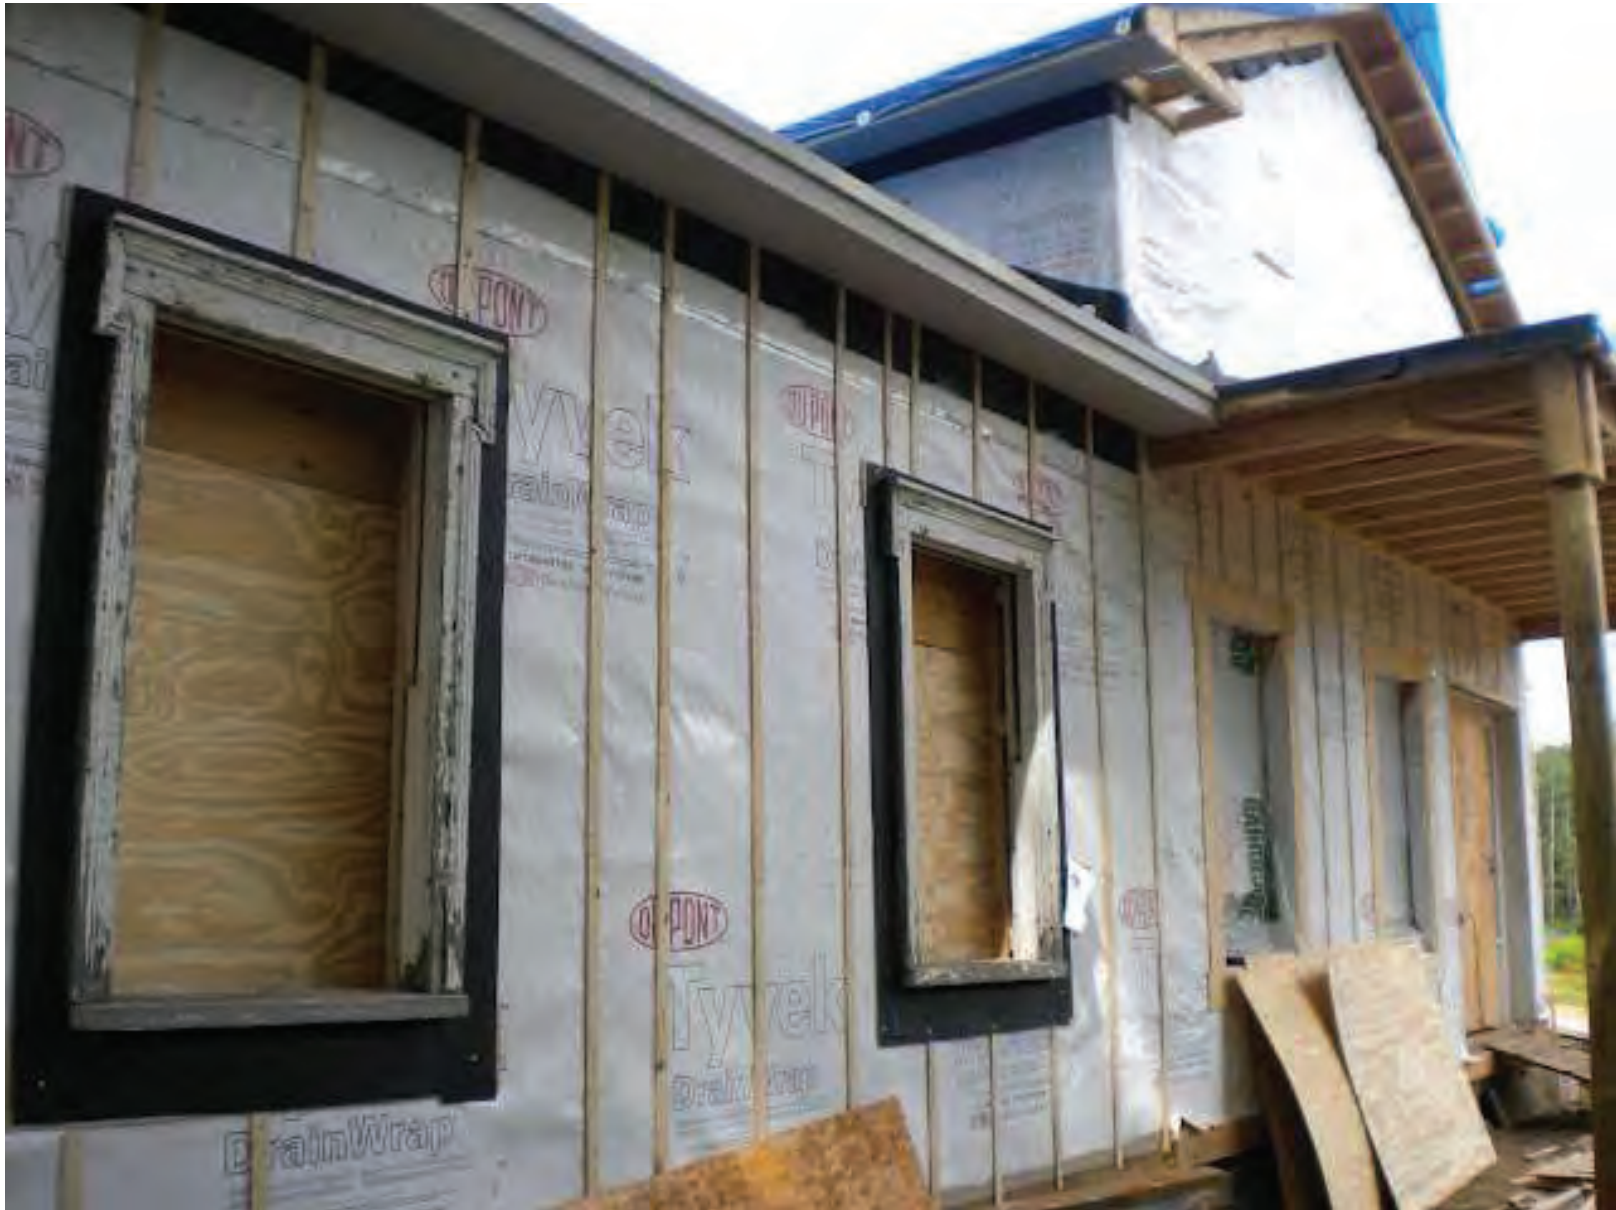
**Exterior walls furred out for siding ventilation**

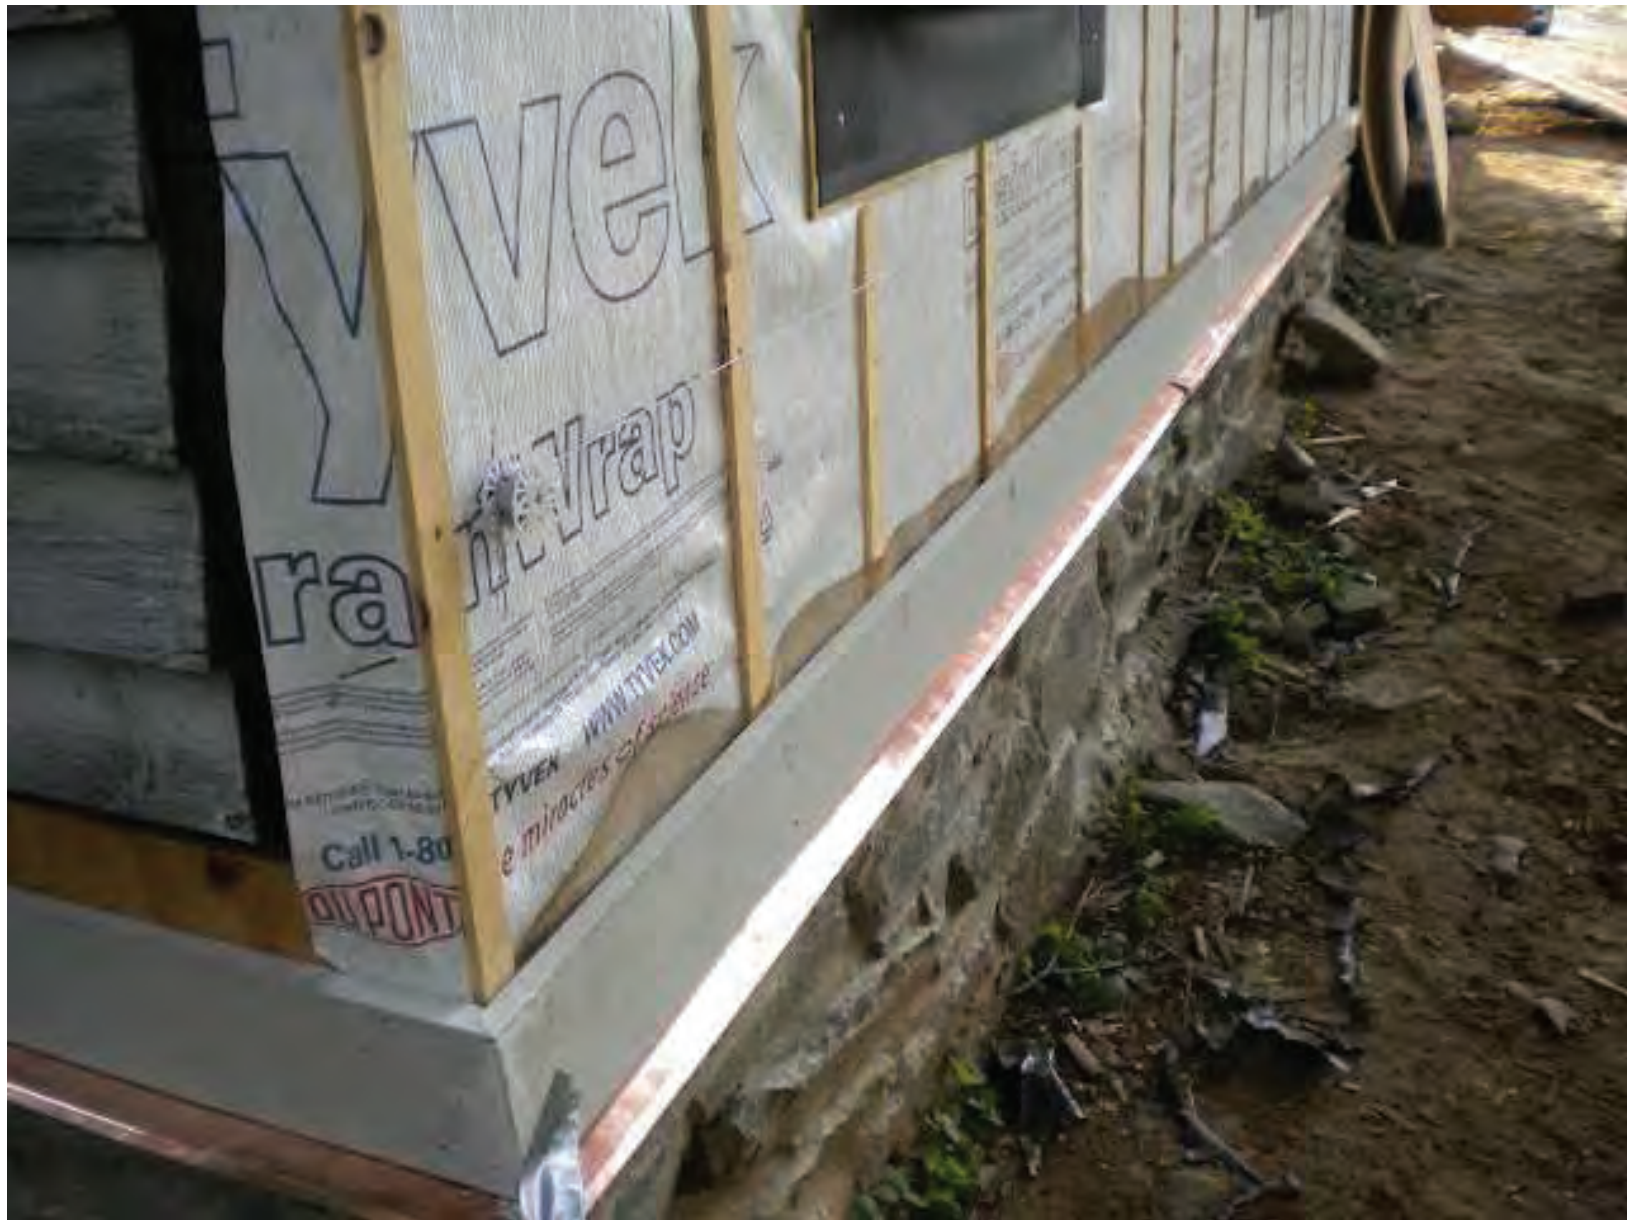
drip edge and insect screen installed along sill

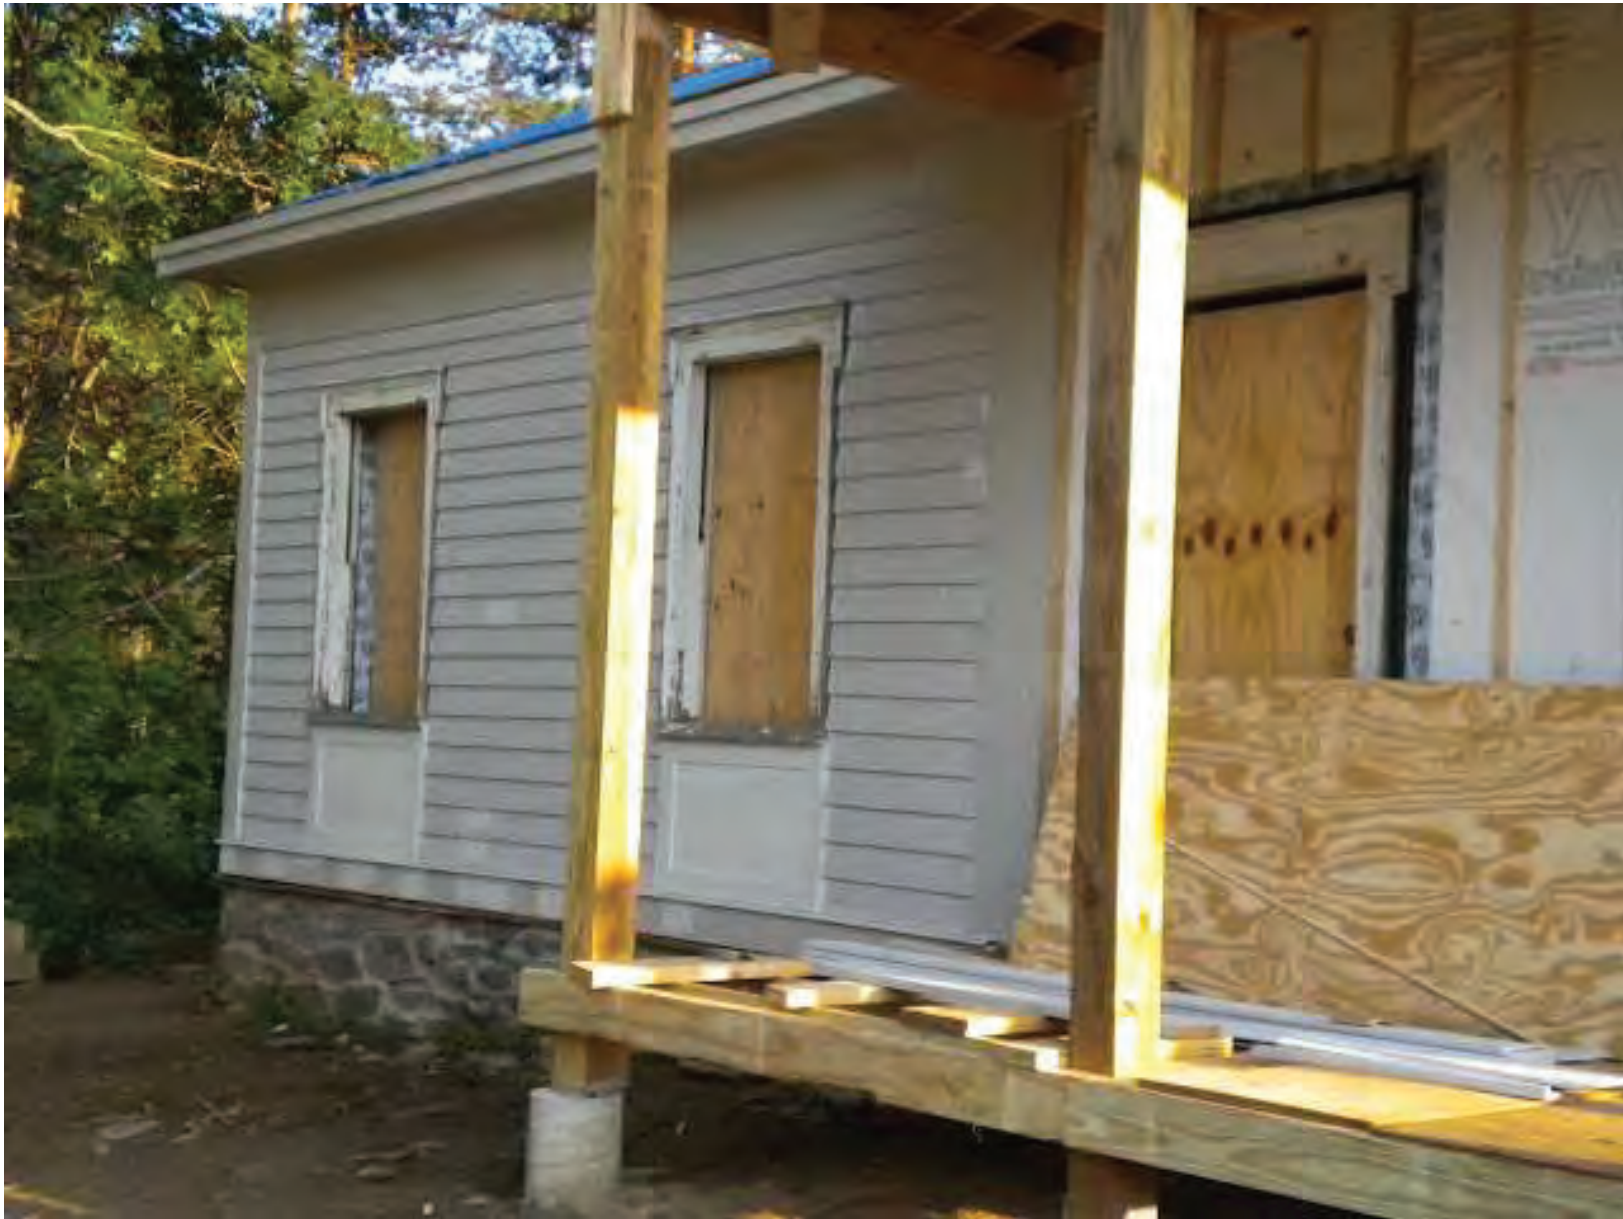
**new siding, old trim for south windows**

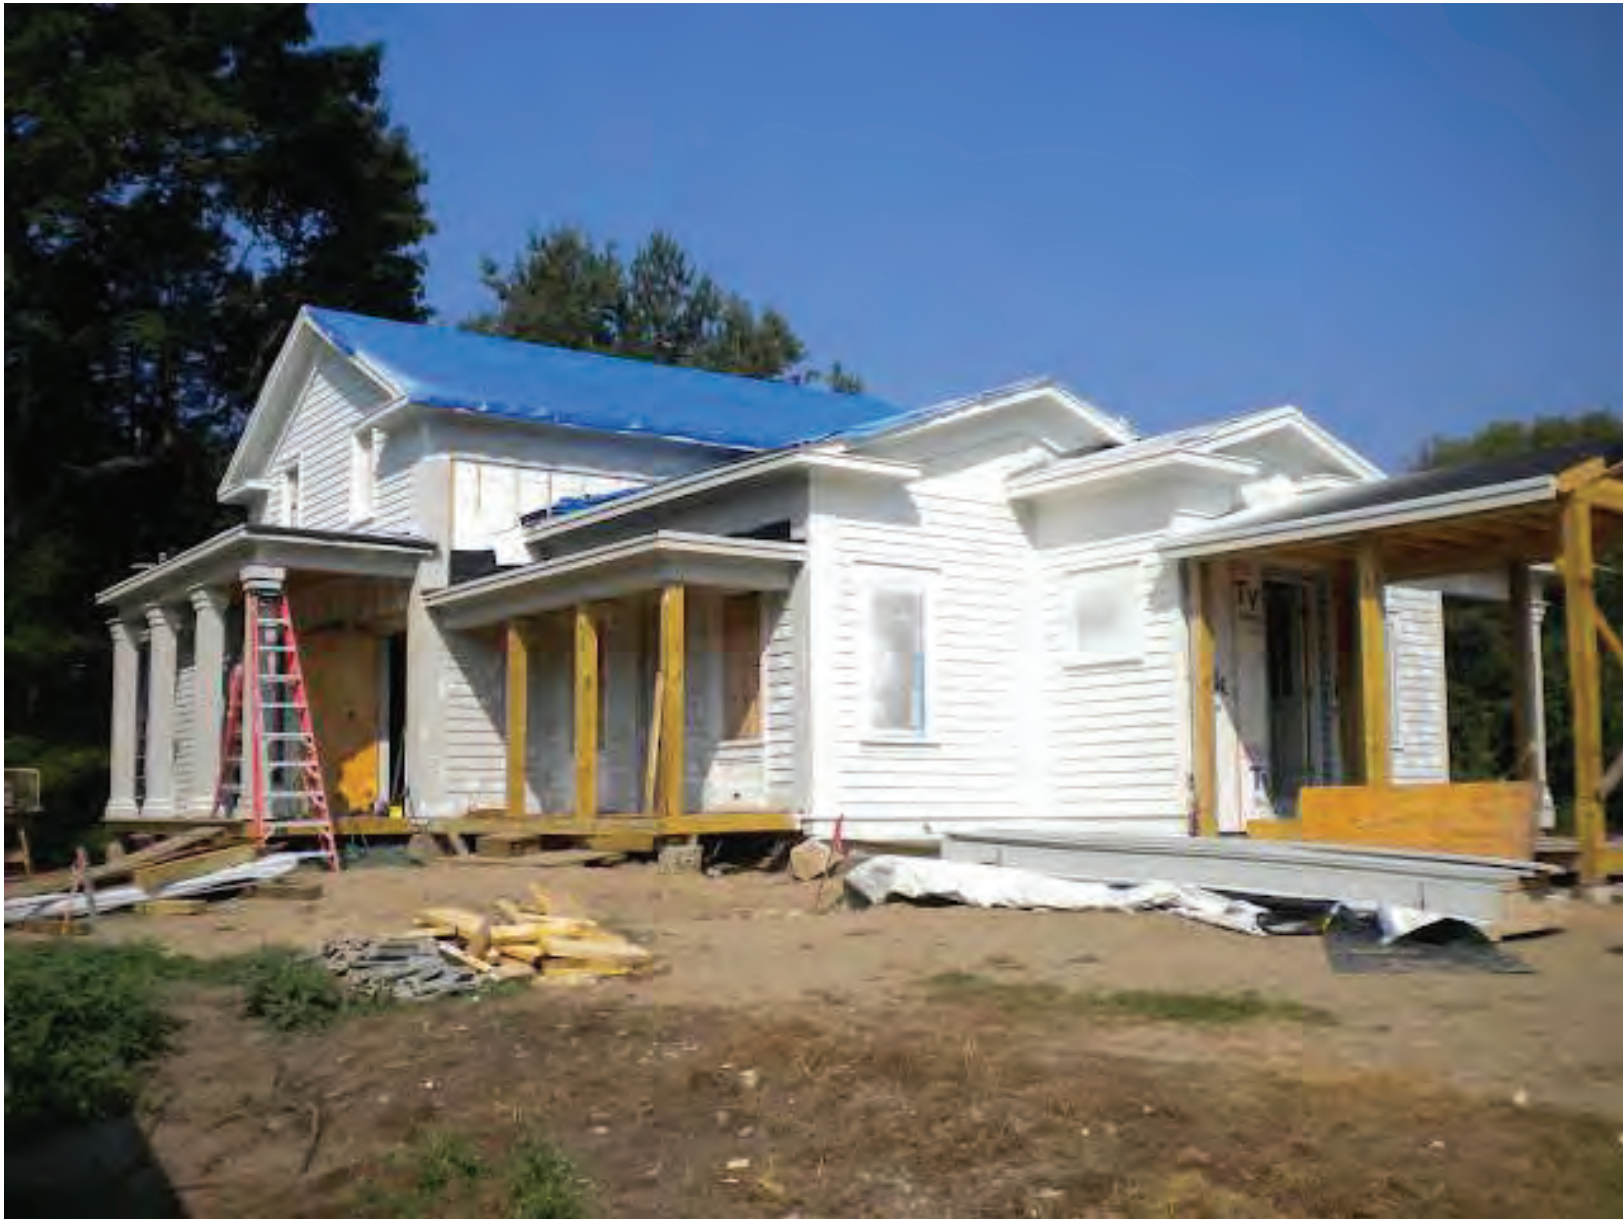
**column reproduction and painting**

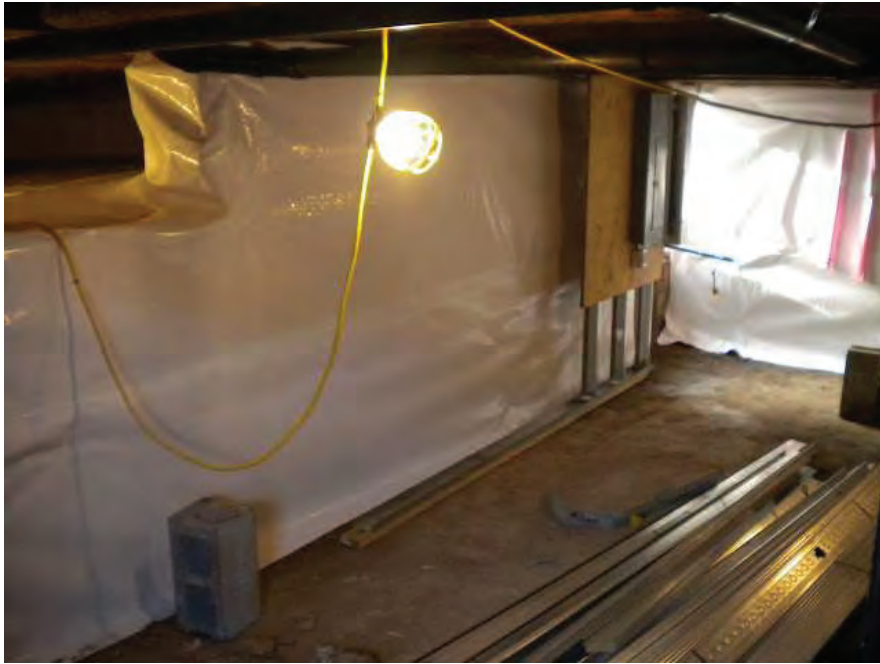
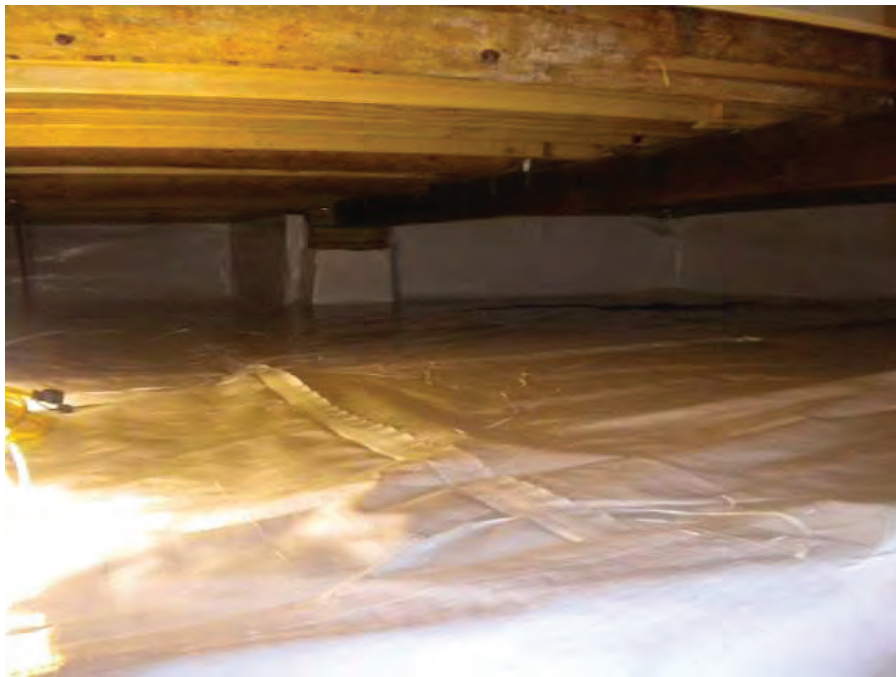
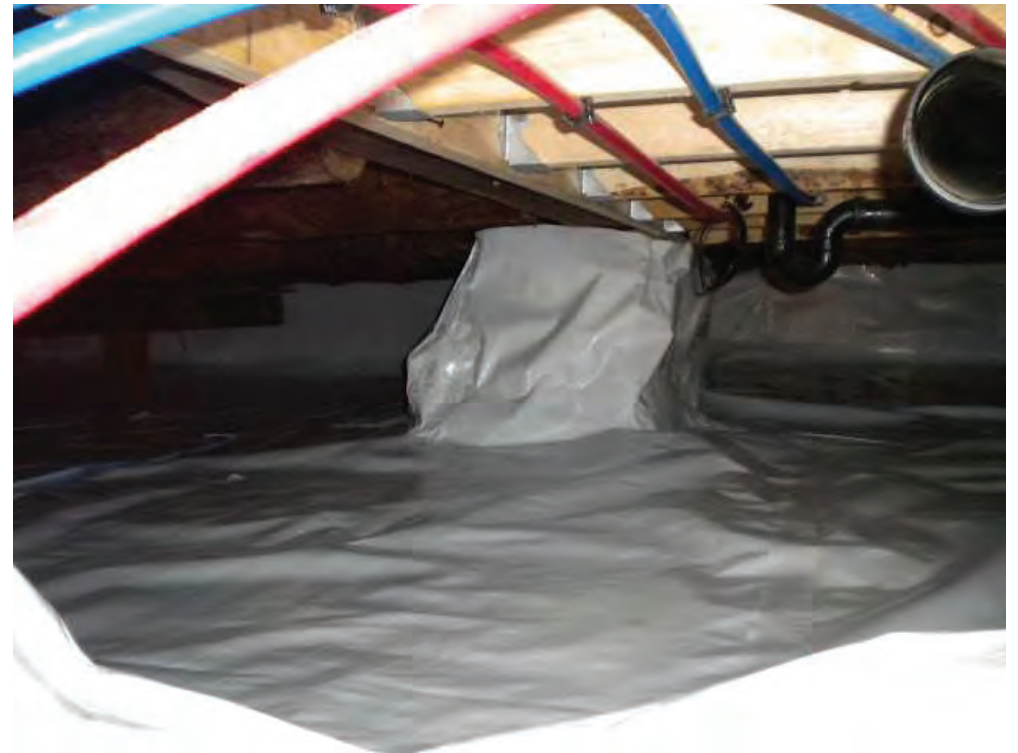
**basement system envelope  
to seal moisture out of structure**

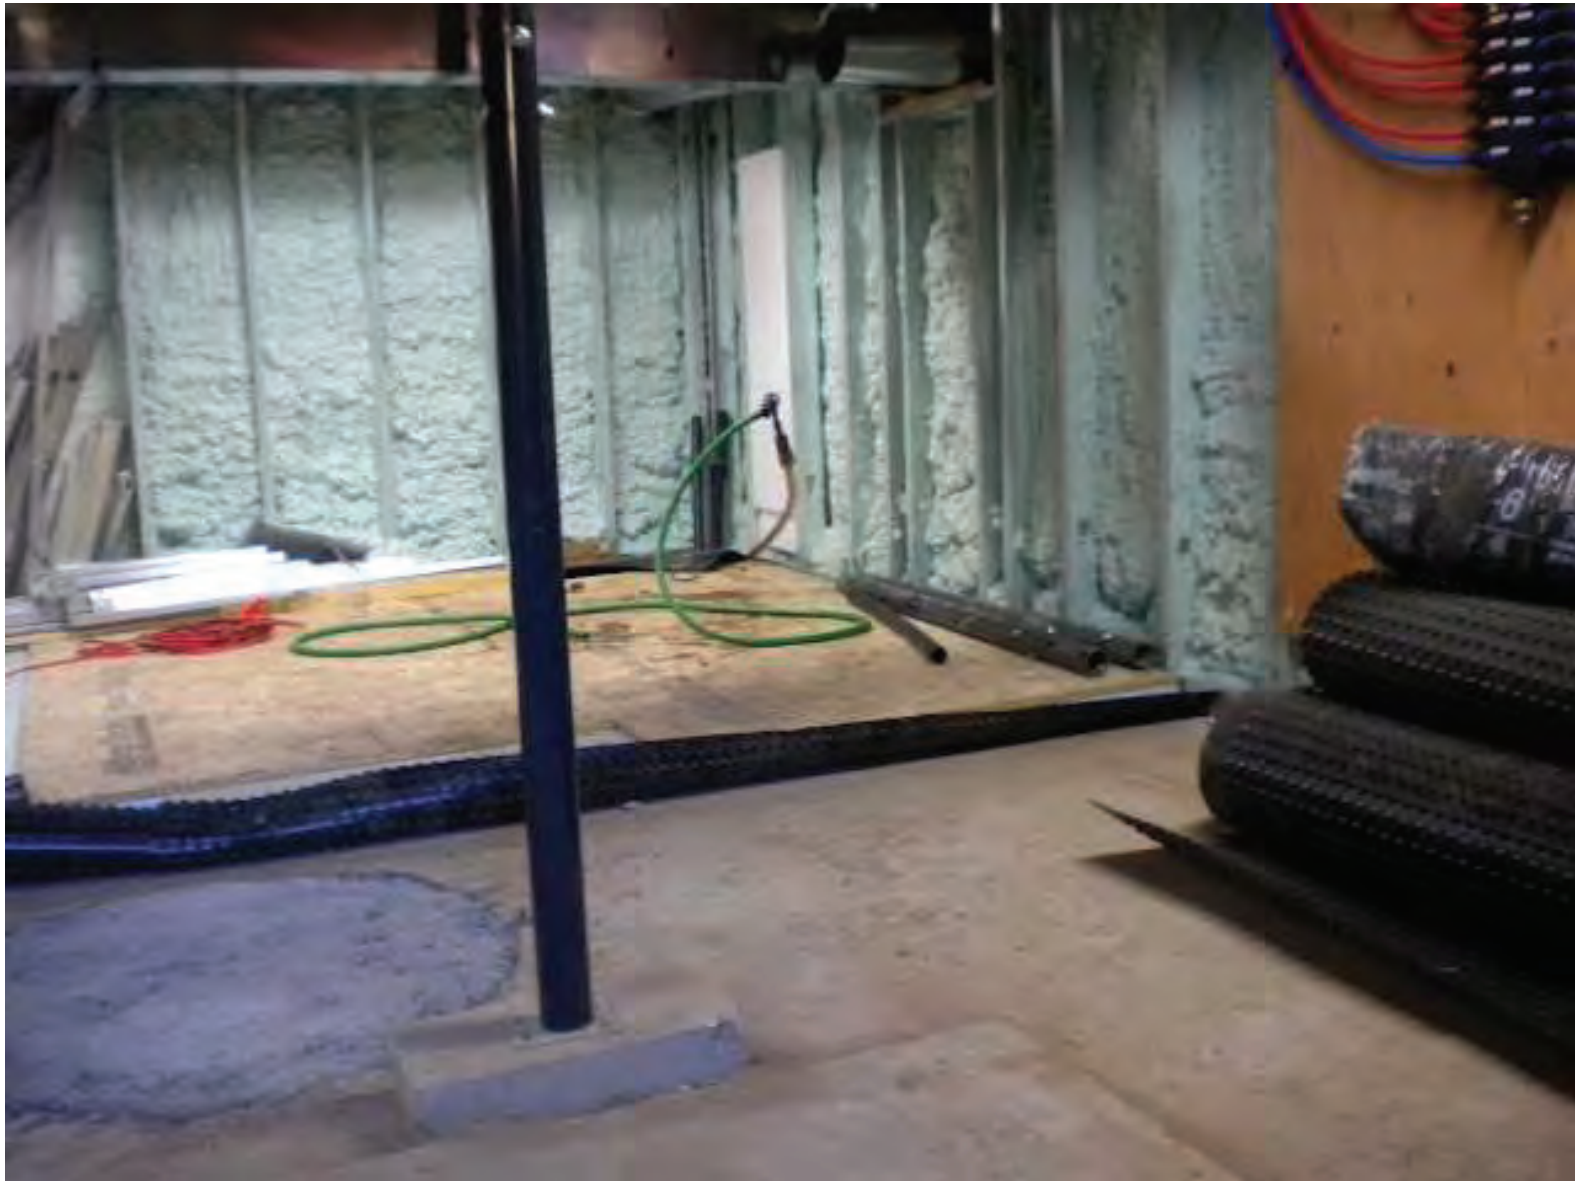
**Platton, vapor barrier over concrete to reduce water vapor into structure.  
Note circle of concrete where old interior well was.**

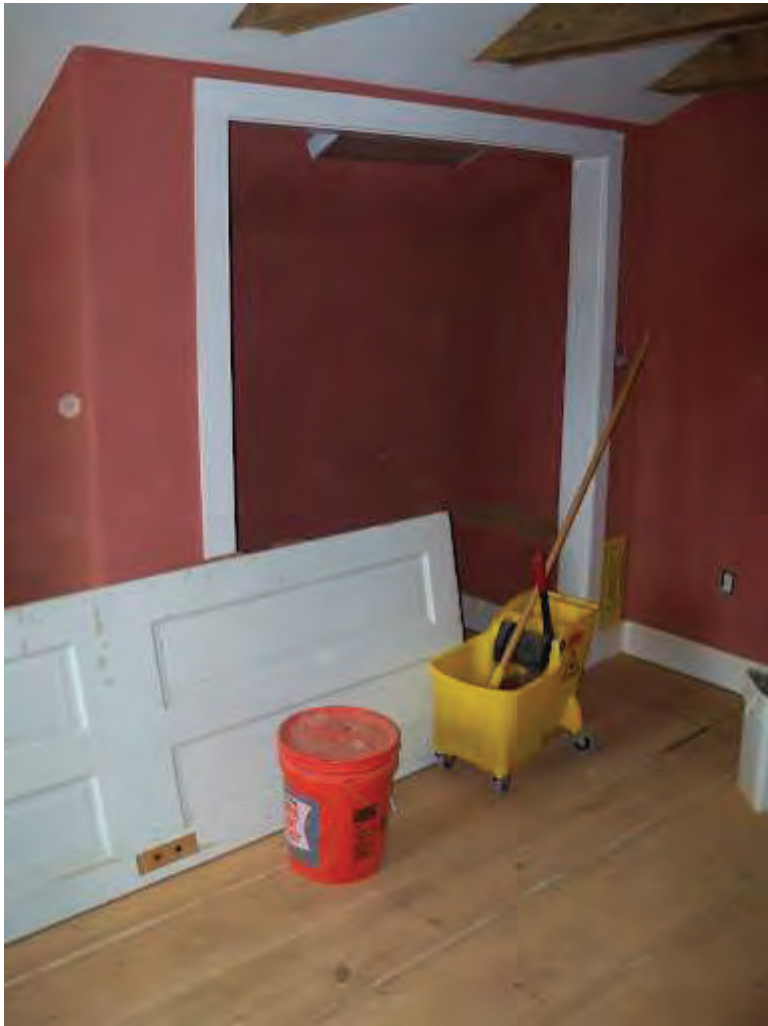
**upstairs floors being finished, Albany  
Historic Doors- Reuse  
American Clay walls- naturally green**

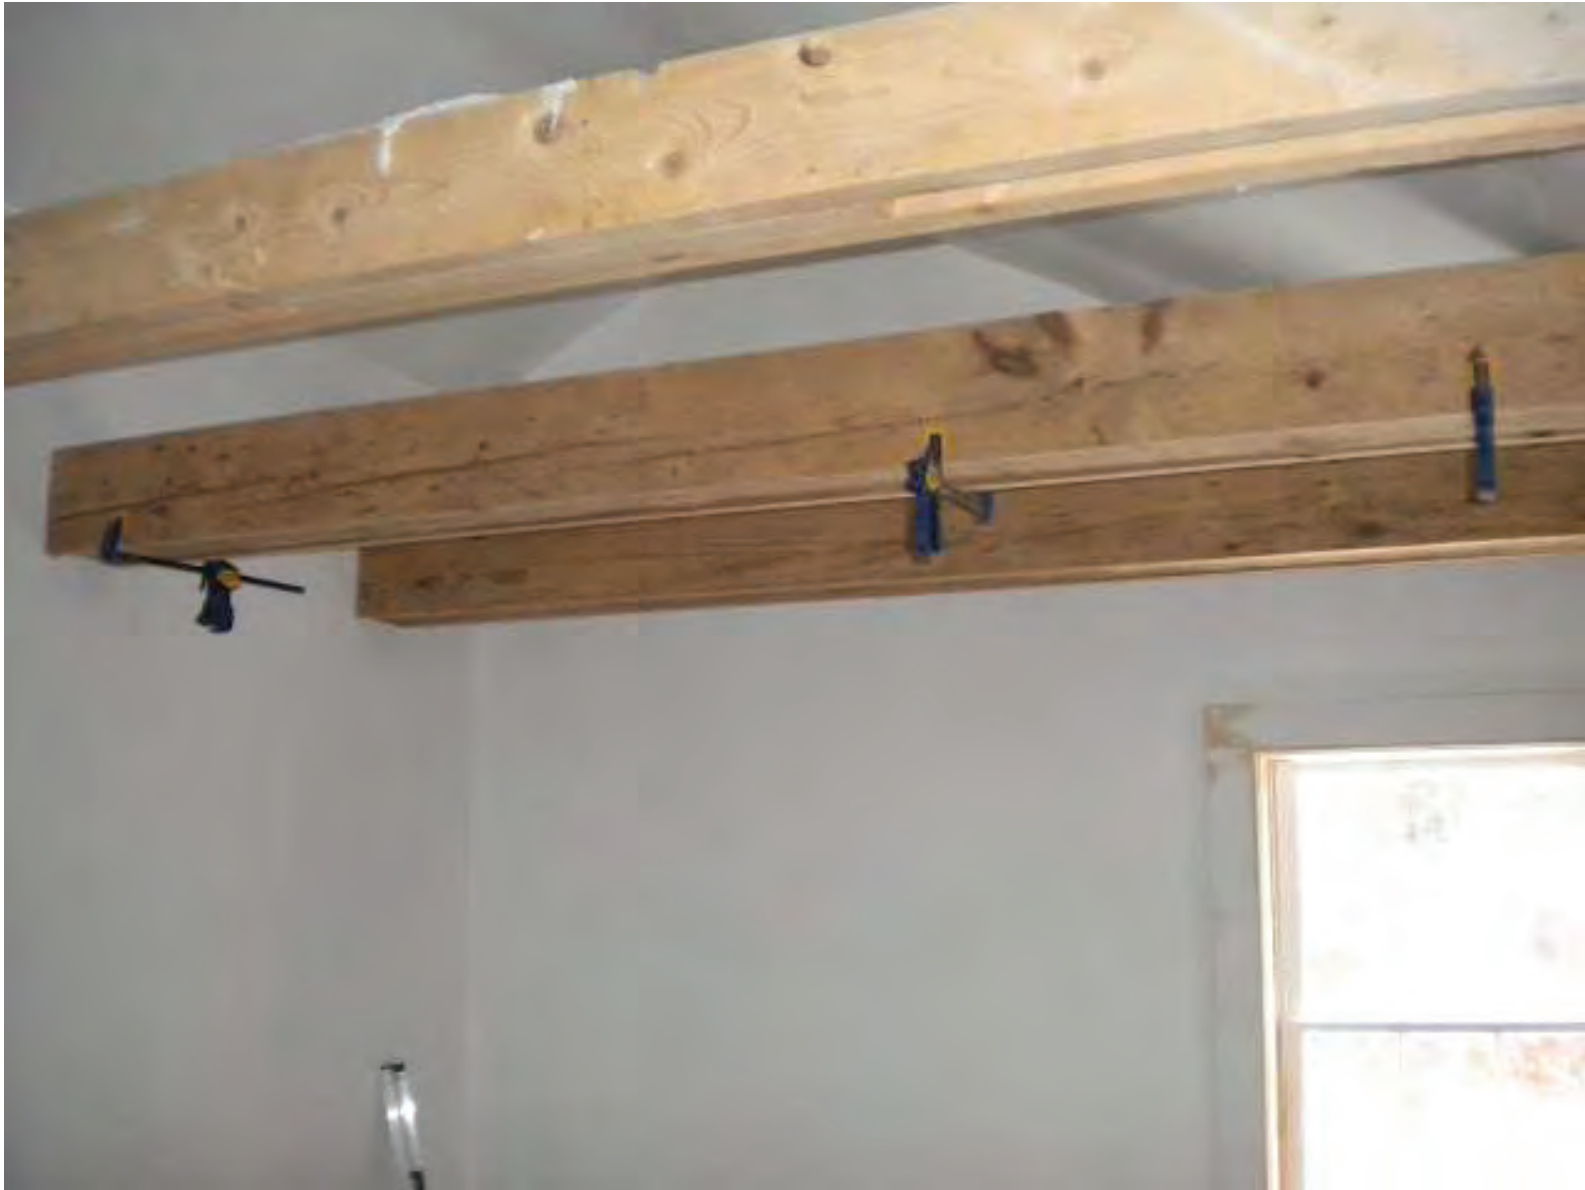
**reuse of old kitchen floor boards to box in collar ties**

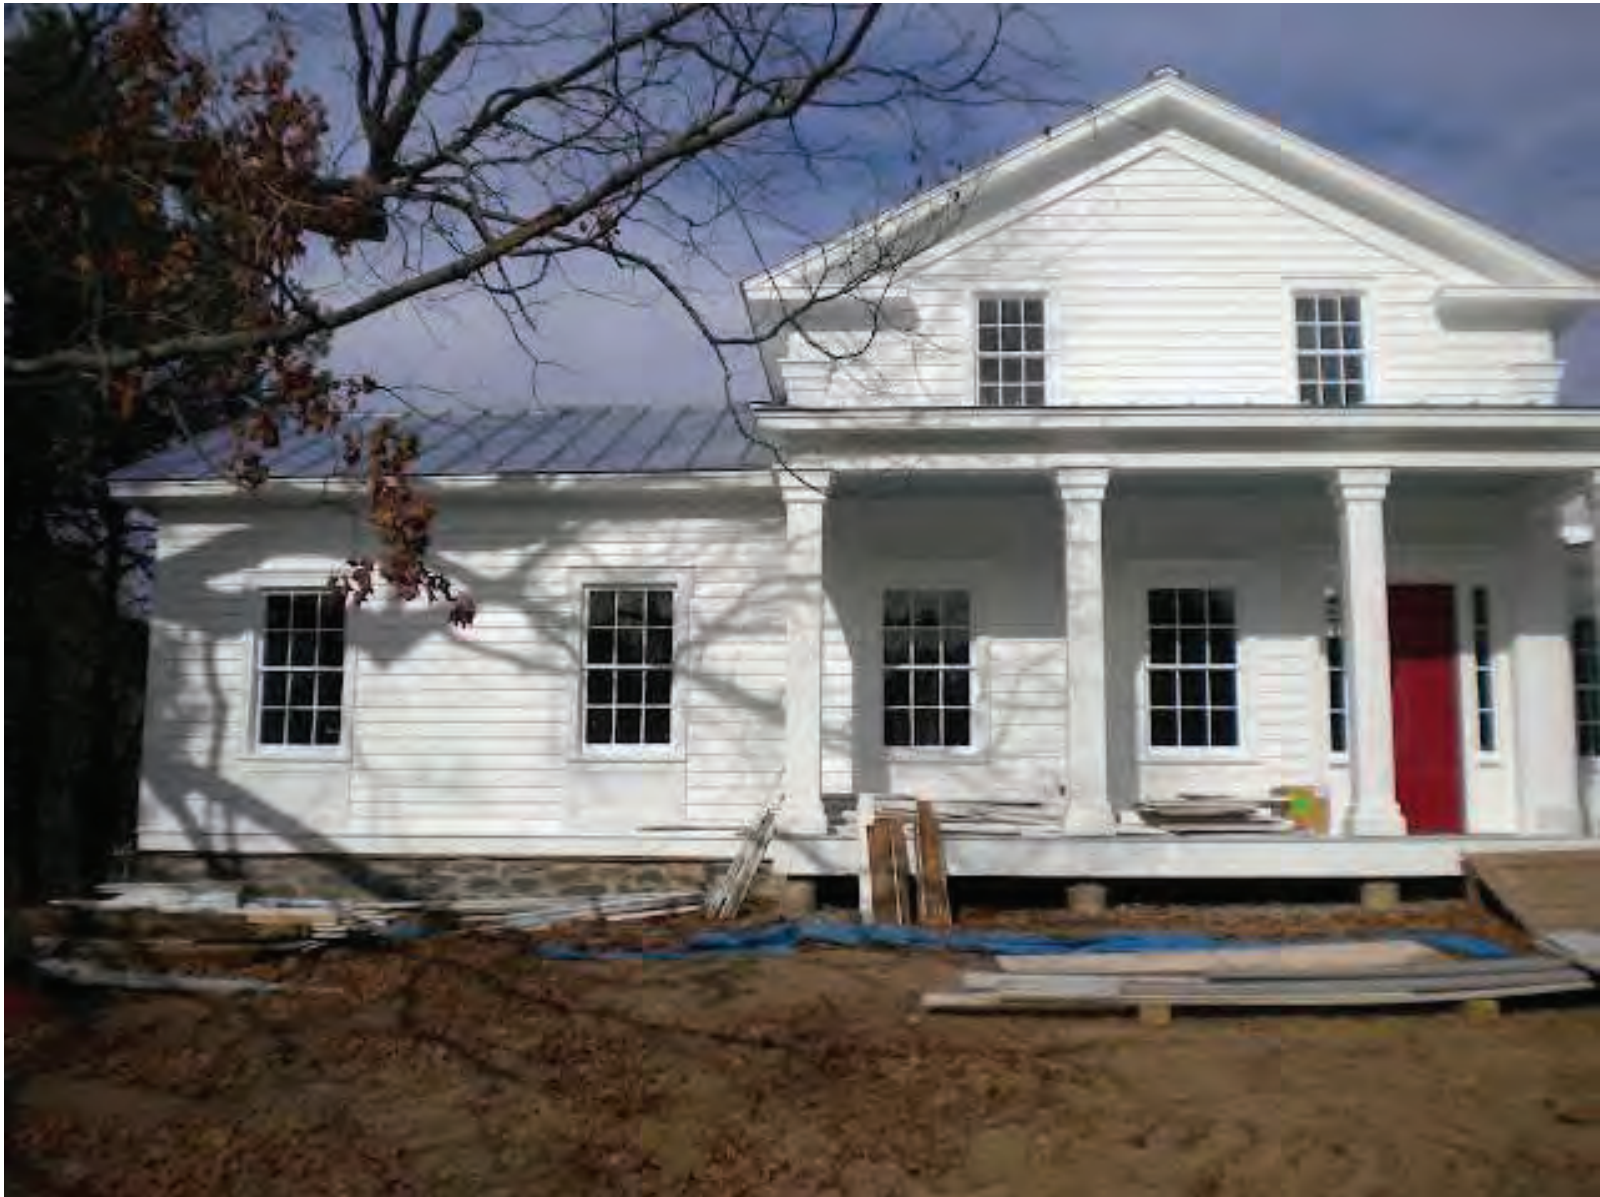
**Rebuilt original windows, interior and exterior storms added later**
